PRELIMINARY SITE INVESTIGATION

Former Batlow Cannery

1 Leaburn Avenue,

February 2021

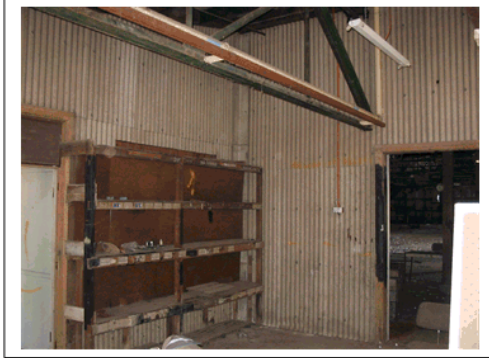
Plate 5: C & D Building – Asbestos Corrugated Wall Sheet

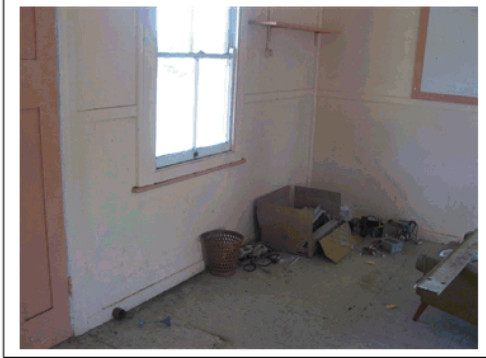
Plate 9: Display Centre – Internal wall sheet

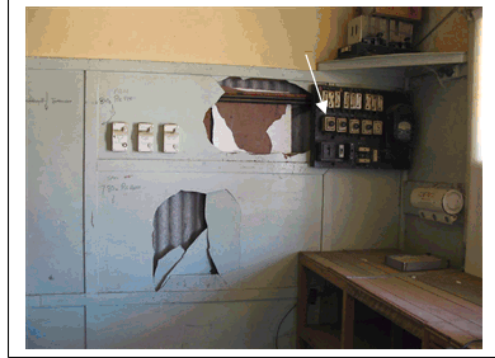
Plate 10: Display Centre – Cracked internal wall sheet and Electrical Switchboard Backing Sheet

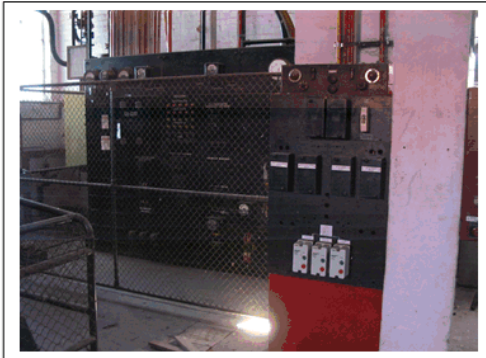
Plate 11: Cannery Switchroom - Asbestos Switchboard Panel

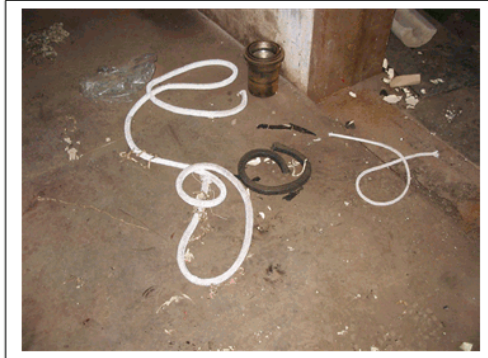
Plate 13: C & D Building – Sprinkler Room
– Loose Valve Packing

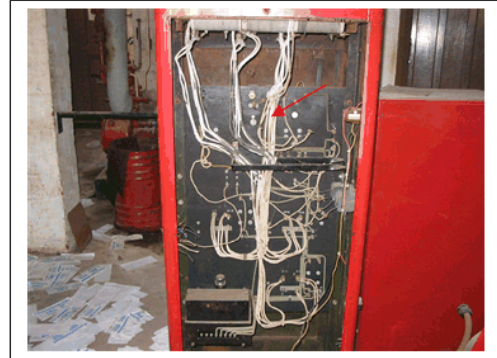
Plate 14: C & D Building – Sprinkler Room
– Cable Sheath on cables in control panel of
Compressor No. 1

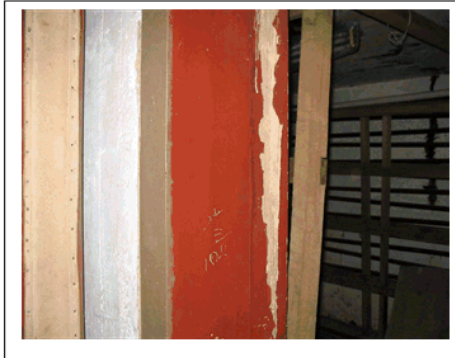
Plate 15 : C & D Building – architrave to cool room in sprinkler room – poor condition (**Sample Pb1**: 34% - Lead Paint).

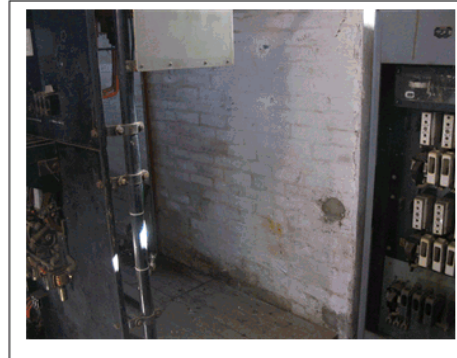
Plate 16 : C & D Building – wall paint in Sprinkler Room (**Sample Pb2**: 0.014% - Non-Lead Paint).

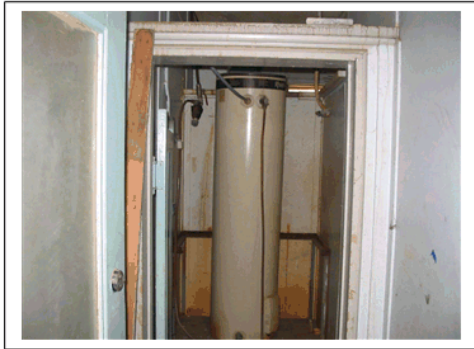
Plate 19 : Fibre glass insulation to Hot Water Heater of the Offices Areas (West) – Cannery Building

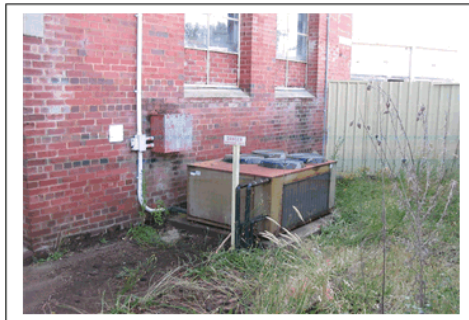
Plate 24: Air Conditioning Unit

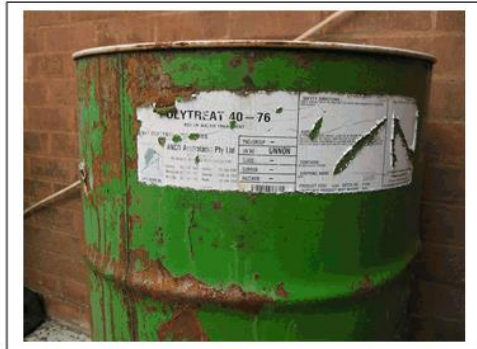
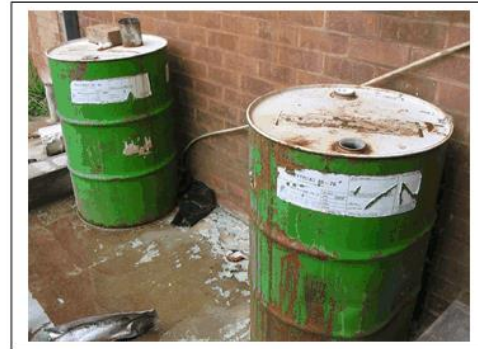
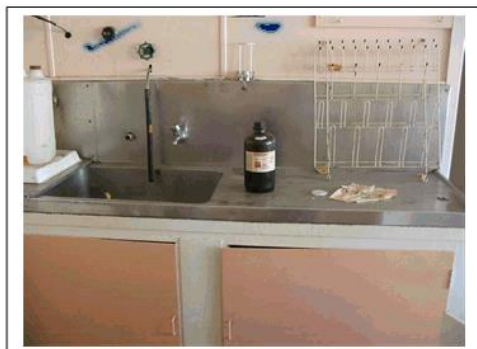
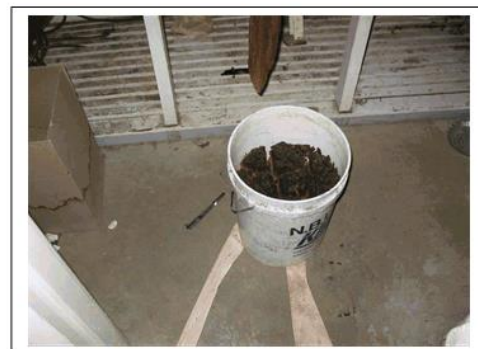
Plates 30 and 31. Residual Chemicals in Cannery Lab

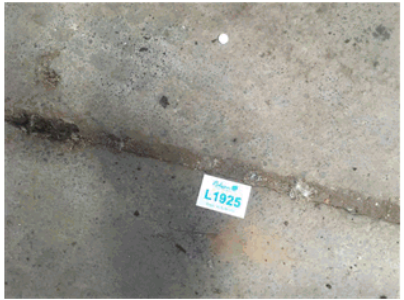
ASBESTOS - Bottling Warehouse				
SAMPLE NO.	TRACKER LOCATION NO.	LOCATIONS	MATERIAL DESCRIPTION	PHOTOGRAPH
L1925	N/A	Ground floor throughout - Floor joins	Bituminous product (Non-Friable)

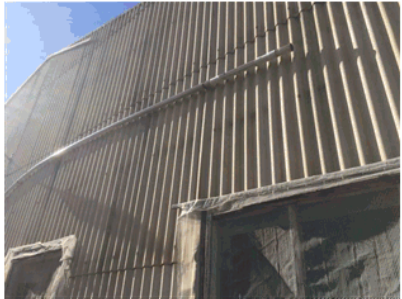
ASBESTOS - Can Shed				
SAMPLE NO.	TRACKER LOCATION NO.	LOCATIONS	MATERIAL DESCRIPTION	PHOTOGRAPH
L1919	N/A	Exterior throughout - Walls and roof	Cement sheet (Non-Friable)

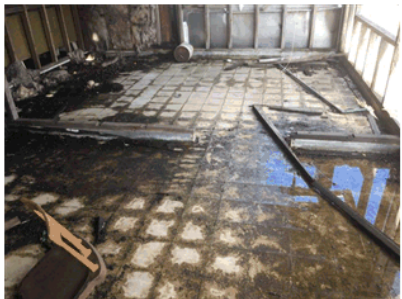
L1920	N/A	Ground floor Chemical Laboratory - Floor	Vinyl floor tile (Non-Friable)

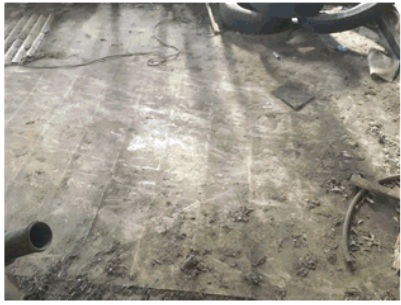
ASBESTOS - Can Shed				
SAMPLE NO.	TRACKER LOCATION NO.	LOCATIONS	MATERIAL DESCRIPTION	PHOTOGRAPH
RA L1920	N/A	Ground floor Amenities Room - Floor	Vinyl floor tile (Non-Friable)

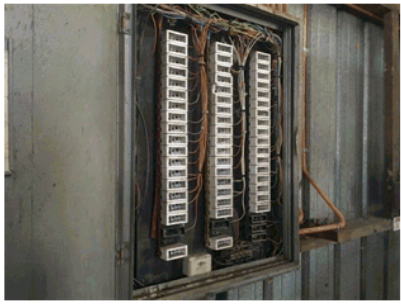
VA04	N/A	Ground floor open warehouse - Electrical switchboard	Bituminous product (Non-Friable)

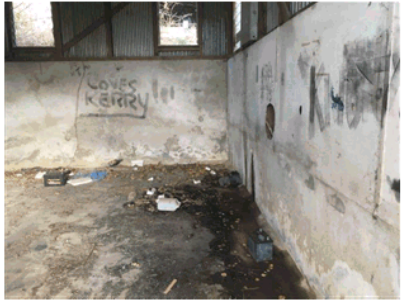
ASBESTOS - Cold Warehouse				
SAMPLE NO.	TRACKER LOCATION NO.	LOCATIONS	MATERIAL DESCRIPTION	PHOTOGRAPH
C2472	N/A	Ground floor storage area - Walls	Sheet (Non-Friable)

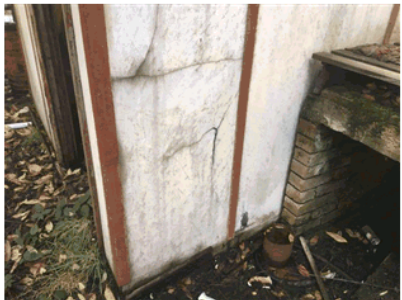
RA C2471	N/A	Ground floor Ammonia Control Room office area - Walls	Sheet (Non-Friable)

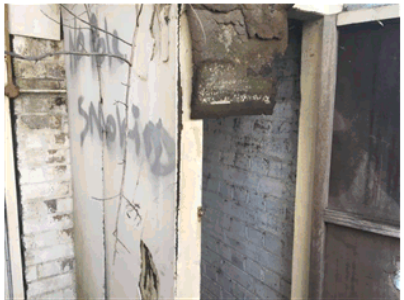
ASBESTOS - Collating and Dispatch				
SAMPLE NO.	TRACKER LOCATION NO.	LOCATIONS	MATERIAL DESCRIPTION	PHOTOGRAPH
RA C2471	N/A	Ground floor Boiler Room - Walls to storage cupboard	Sheet (Non-Friable)

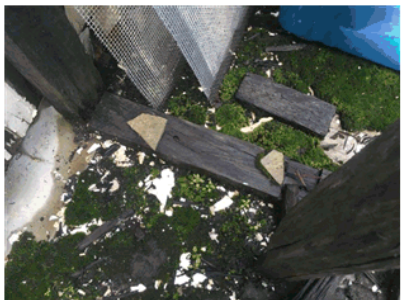
RA C2471	N/A	Ground floor offices - Ground surfaces	Sheet (Non-Friable)

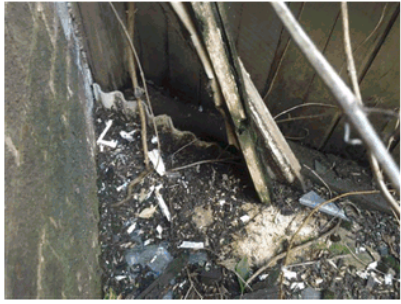
ASBESTOS - Collating and Dispatch				
SAMPLE NO.	TRACKER LOCATION NO.	LOCATIONS	MATERIAL DESCRIPTION	PHOTOGRAPH
RA C2471	N/A	Exterior throughout - Form work to external area	Sheet (Non-Friable)

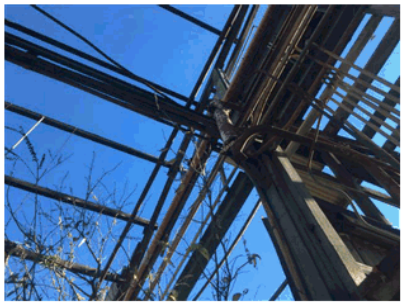
L1916	N/A	Ground floor open warehouse north end - Hot water pipe	Pipe lagging (fibrous) (Friable)

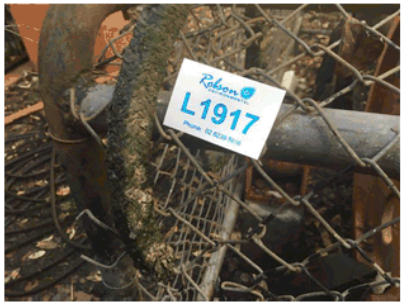
ASBESTOS - Collating and Dispatch				
SAMPLE NO.	TRACKER LOCATION NO.	LOCATIONS	MATERIAL DESCRIPTION	PHOTOGRAPH
L1917	N/A	Ground floor Ammonia Engine room - Loose rope insulation	Rope (Non-Friable)

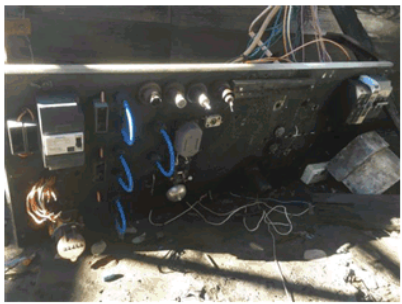
VA02	N/A	Ground floor open warehouse - Electrical switchboard	Bituminous product (Presumed Non-Friable)

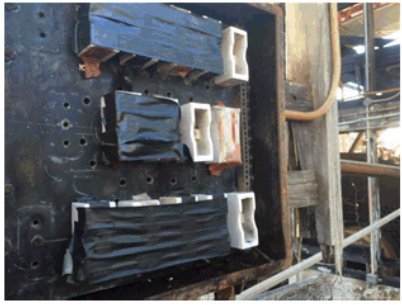
ASBESTOS - Collating and Dispatch				
SAMPLE NO.	TRACKER LOCATION NO.	LOCATIONS	MATERIAL DESCRIPTION	PHOTOGRAPH
VA02	N/A	Ground floor open warehouse - Electrical switchboard	Bituminous product (Non-Friable)

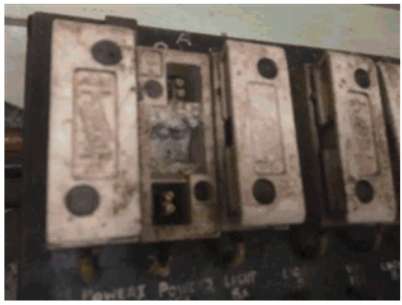
ASBESTOS - Display Centre				
SAMPLE NO.	TRACKER LOCATION NO.	LOCATIONS	MATERIAL DESCRIPTION	PHOTOGRAPH
RA L1908	N/A	Ground floor storage room - Fuse insulation	Millboard (Friable)

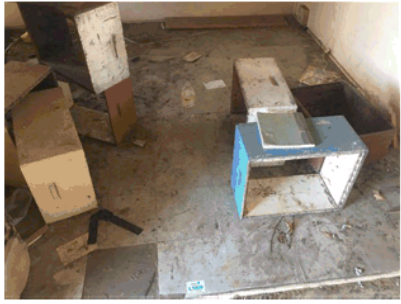
ASBESTOS - Display Centre				
SAMPLE NO.	TRACKER LOCATION NO.	LOCATIONS	MATERIAL DESCRIPTION	PHOTOGRAPH
L1929	N/A	Ground floor throughout internal area - Floor	Vinyl floor tile (Non-Friable)

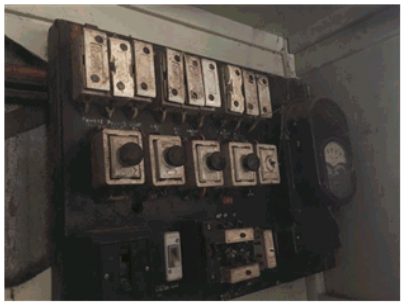
VA06	N/A	Ground floor storage room - Electrical switchboard	Bituminous product (Non-Friable)

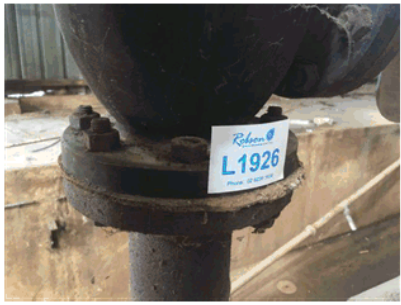
ASBESTOS - Retorts Warehouse				
SAMPLE NO.	TRACKER LOCATION NO.	LOCATIONS	MATERIAL DESCRIPTION	PHOTOGRAPH
L1926	N/A	Ground floor throughout - Pipe flange joints	Gaskets (rope/woven) (Friable)

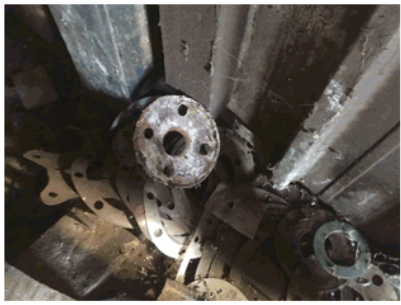
RA L1926	N/A	Ground floor workshop - Loose gaskets	Gaskets (compressed) (Non-Friable)

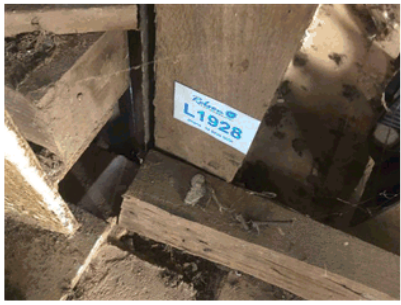
ASBESTOS - Transformers Building				
SAMPLE NO.	TRACKER LOCATION NO.	LOCATIONS	MATERIAL DESCRIPTION	PHOTOGRAPH
L1928	N/A	Ground floor Transformers Room - Ground and timber studs	Sheet debris (Non-Friable)

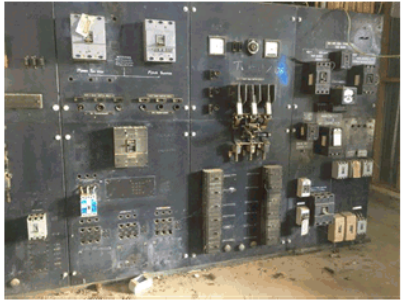
ASBESTOS - Transformers Building				
SAMPLE NO.	TRACKER LOCATION NO.	LOCATIONS	MATERIAL DESCRIPTION	PHOTOGRAPH
VA06	N/A	Ground floor Transformers Room - Electrical switchboard	Bituminous product (Non-Friable)

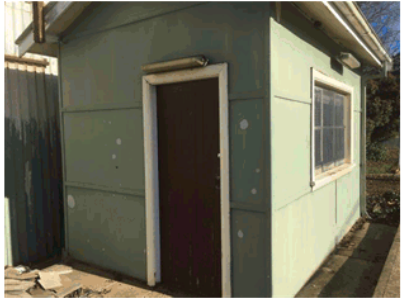
ASBESTOS - Weigh Bridge Office				
SAMPLE NO.	TRACKER LOCATION NO.	LOCATIONS	MATERIAL DESCRIPTION	PHOTOGRAPH
RA L1930	N/A	Ground floor throughout - Walls, ceiling and eave soffits	Sheet (Non-Friable)

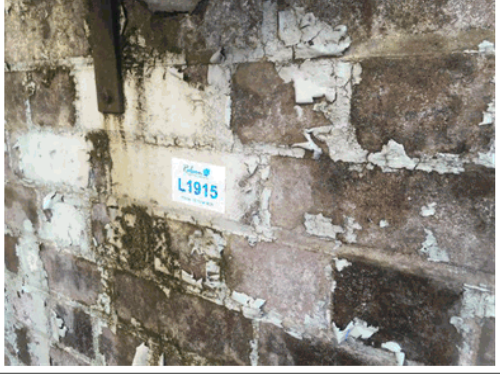
LEAD PAINT - Collating and Dispatch			
ITEM NO.	LOCATION	Lead %	PHOTOGRAPH
PB1556	Boiler Room - walls adjacent to boiler	0.34

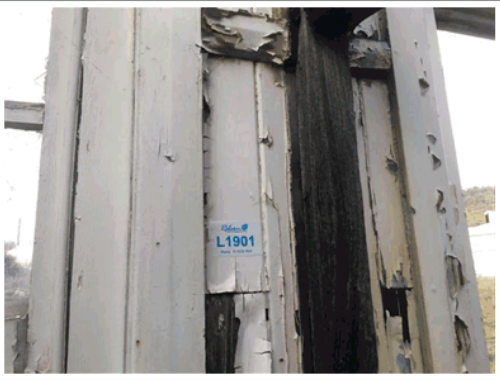
PB1555	Ground floor offices - Walls	1.5

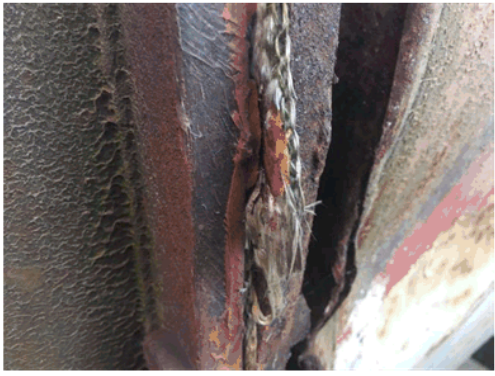
SMF - Collating and Dispatch			
ITEM NO.	LOCATION	MATERIAL TYPE	PHOTOGRAPH
SMF130 6	Ground floor Boiler Room	internal insulation

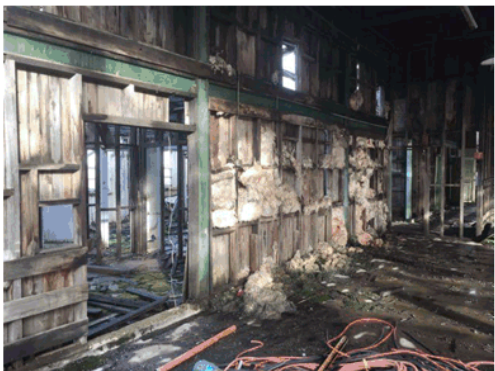
SMF130 8	Offices and open warehouse	wall cavities and floor

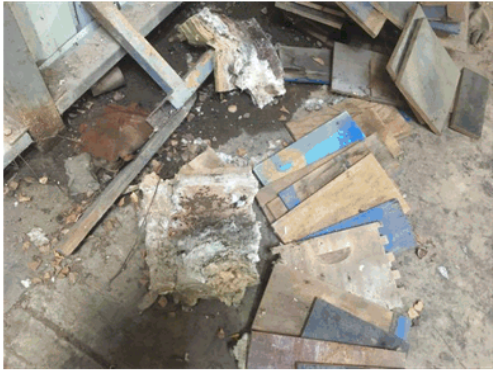
SMF - Can Shed			
ITEM NO.	LOCATION	MATERIAL TYPE	PHOTOGRAPH
SMF130 9	Open warehouse	throughout floor

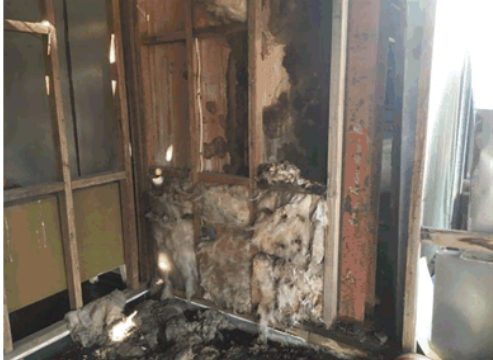
SMF - Bottling Warehouse			
ITEM NO.	LOCATION	MATERIAL TYPE	PHOTOGRAPH
SMF130 7	Ground floor laboratories	wall cavities and floor

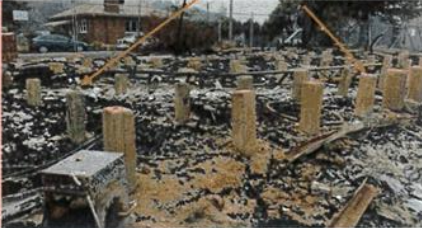
Asbestos detected				Presumed to contain asbestos			No asbestos detected	
LOCATION	MATERIAL	SAMPLE ID	Approx Qty m ²	TYPE & CONDITION	RISK OF EXPOSURE	RESULT	COMMENTS	PHOTO
Block E - Brick piers	Sheet Packers	A2 ref	-	Friable - poor	Low. Moderate if disturbed	Identified as referenced material	Remove whole block as asbestos contaminated waste

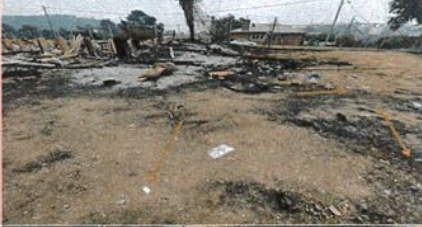
Area between Block E and A - Potentially previously covered by grass	Sheet Packers	A2 ref	-	Friable - poor	Low. Moderate if disturbed	Identified as referenced material	Remove whole block as asbestos contaminated waste

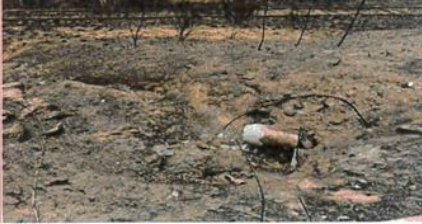
Fire damaged pipe on the eastern end of Block H	Sheet & debris	A3	-	Friable - poor	Low. Moderate if disturbed	Chrysotile Asbestos Detected	Remove as asbestos contaminated waste

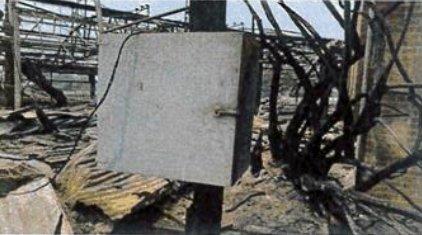
Asbestos detected				Presumed to contain asbestos			No asbestos detected	
LOCATION	MATERIAL	SAMPLE ID	Approx Qty m ²	TYPE & CONDITION	RISK OF EXPOSURE	RESULT	COMMENTS	PHOTO
Electrical switch board backing sheet to Block A	Sheet	-	-	Presumed to be fire damaged	Presumed to contain asbestos	-	Remove during asbestos removal work

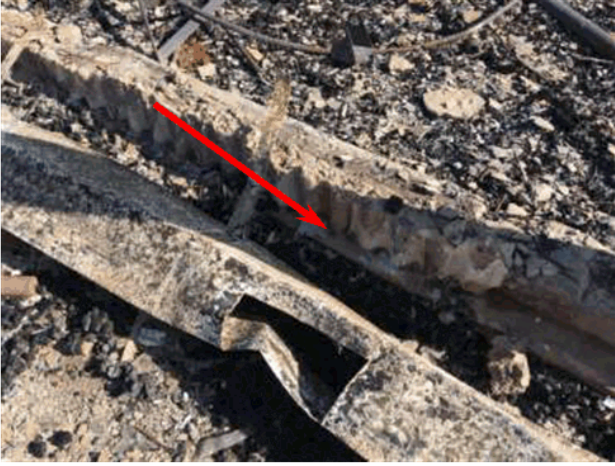
Sample Number	Location (refer Plan)	Material	Photographs
Visually assessed 3	Formwork to building opposite soil sample 4	Broken formwork sheeting

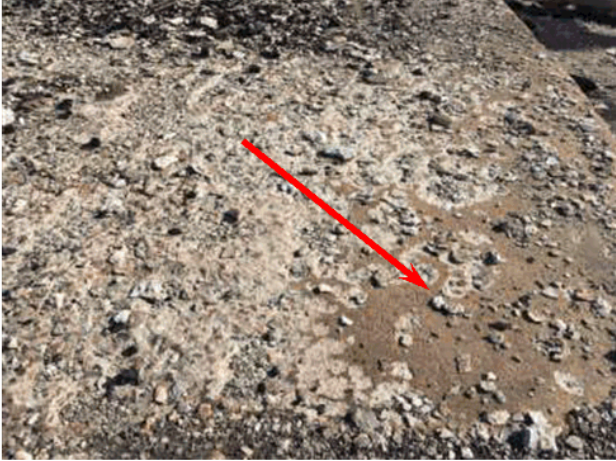
Photo Number	Locations	Material	Photographs
1	Building A southern side adjacent building footprint	Concrete fragments
