## **11.6 WILLIGOBUNG FIRE SHED - ATTACHMENTS**

**NSW Rural Fire Service  
Willigobung Brigade Station**

**Recommendations Report**

**RES2305.42.117**

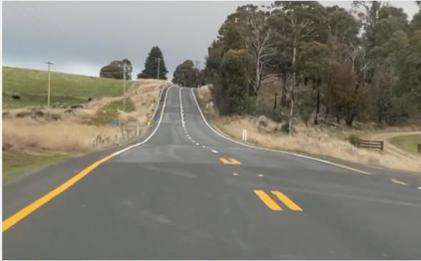
ID	General Observations	Photos / Reference	Recommended Actions
GO-1	<p>The transition of yellow to white pavement marking occurs approximately 10m south of the Willigobung Road intersection. The linemarking colour transition indicates a likely area for snow and ice. Consideration should be given to relocating the transition to the higher elevation further up the hill, approximately 350m south of the intersection.</p>

<p>Looking south on Batlow Road</p>	<p><b>SHORTER TERM / LOWER COST</b></p> <ul style="list-style-type: none"> <li>- Liase with TfNSW and Snowy Valleys Council to investigate the warrants of Australian Standards 1742, TfNSW Delineation Manual and other relevant standards and guidelines to determine the most appropriate location for the Snow &amp; Ice Area transition.</li> </ul> <p><b>LONGER TERM / HIGHER COST</b></p> <ul style="list-style-type: none"> <li>- Implimentation a conforming Snow &amp; Ice Area signage and linemarking scheme.</li> </ul>

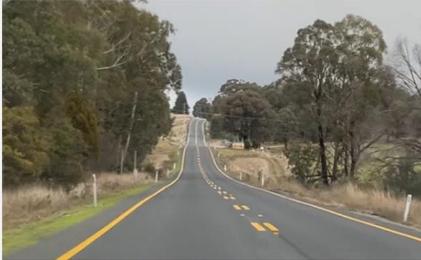
GO-2	<p>At the time of inspection, dense roadside vegetation was observed along both sides of Batlow Road. This vegetation will require regular maintenance to ensure unrestricted sight lines to/from the Willigobung Brigade Station access.</p>

<p>Looking south on Batlow Road</p>

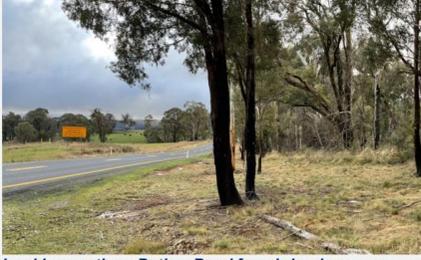
<p>Looking north on Batlow Road from brigade access.</p>	<p><b>SHORTER TERM / LOWER COST</b></p> <ul style="list-style-type: none"> <li>- Liase with TfNSW and Snowy Valleys Council regarding the establishment of hazard free zones and sight line envelopes as indicated by Attachment A – Stage 1: Shorter Term / Lower Cost Layout.</li> </ul> <p><b>LONGER TERM / HIGHER COST</b></p> <ul style="list-style-type: none"> <li>- Liase with TfNSW and Snowy Valleys Council regarding regular and ongoing maintenance of roadside vegetation to ensure that established hazard free zones and sight line envelopes are retained as per as indicated by Attachment A – Stage 1: Shorter Term / Lower Cost Layout.</li> </ul>

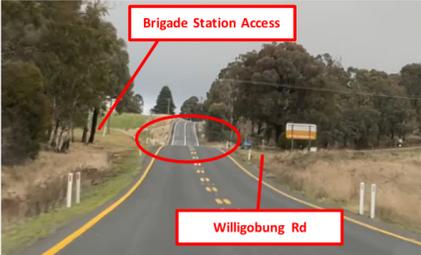
ID	Location	Photos / Reference	Description of Deficiency & Likely Consequence	Likelihood	Severity	Risk Level	Recommended Actions	Likelihood	Severity	Risk Level
ID-1	Batlow Road Sight Restriction

<p>Looking south on Batlow Road towards the intersection/access.</p>	<p>The crest on Batlow Road north of the intersection with Willigobung Road restricts Approach Sight Distance (ASD) and Stopping Sight Distance (SSD) when travelling south on Batlow Road.</p> <p>This may result in high-speed intersection crash types involving road users travelling southbound on Batlow Road and those entering/exiting Willigobung Road and/or the Willigobung Brigade Station access. The likely travel speeds and impact angles may result in a high energy transfer at impact causing serious harm to occupants.</p> <p>NOTES:</p> <ul style="list-style-type: none"> <li>- Should road users travel at excessive speeds it will further reduce the time available for drivers to react and brake.</li> <li>- This hazard will be exacerbated during adverse weather and at night time.</li> </ul>	Unlikely	Serious	H (FSI)	<p><b>SHORTER TERM / LOWER COST</b></p> <p>Implement the recommended actions as shown by Attachment A – Stage 1: Shorter Term / Lower Cost Layout:</p> <ul style="list-style-type: none"> <li>- Provide barrier linemarking through the intersection to prevent overtaking within the intersection.</li> <li>- Provide additional visual cues (signage, guide posts and intersection linemarking) for the approaching/trailing road users that vehicles are to be turning into or out of the Willigobung Brigade Station access (as well as Willigobung Road).</li> <li>- Provide a clear sightline envelope free of obstructions to ensure intervisibility between approaching vehicles on the through road and the entering vehicles from the Willigobung Brigade Station access.</li> <li>- Provide active signage to alert approaching road users that vehicles are to be expected to enter the through road from the Willigobung Brigade Station access.</li> </ul> <p>NOTE: due to the nature of this access, greater consideration is needed. Particularly usage during a high pressure emergency scenario.</p>	Unlikely	Moderate	M

<p><b>LONGER TERM / HIGHER COST</b></p> <p>Implement the recommended actions as shown by Attachment A – Stage 2: Longer Term / Higher Cost Layout:</p> <ul style="list-style-type: none"> <li>- Provide an all weather access to the Willigobung Brigade Stations by realigning the access and installing a storm water culvert.</li> <li>- Provide a basic right turn treatment (BAR) to assist trailing road users to pass a right turning vehicle into the Willigobung Brigade Stations access.</li> </ul>					Rare			
								<b>RESIDUAL RISK</b>		
									<b>RESIDUAL RISK</b>

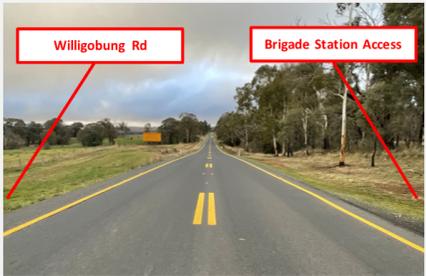
ID	Location	Photos / Reference	Description of Deficiency & Likely Consequence	Likelihood	Severity	Risk Level	Recommended Actions	Likelihood	Severity	Risk Level
ID-2	Intersection/access linemarking, delineation and signage

<p>Looking North on Batlow Road from the intersection/access.</p>	<p>There is a general lack of visual queues on approach to the Willigobung Brigade Station access that would advise approaching drivers that a vehicle may be entering from (or exiting into) the eastern side of Batlow Road.</p> <p>There is no central barrier linemarking on approach to the Willigobung Road intersection restricting overtaking manoeuvres. There is also a lack of guideposts, raised retroreflective pavement markers and warning signage to alert approaching road users that there is an access to the Willigobung Brigade Station.</p>	Rare	Serious	M (FSI)	<p><b>SHORTER TERM / LOWER COST</b></p> <p>Implement the recommended actions as shown by <i>Attachment A – Stage 1: Shorter Term / Lower Cost Layout</i>:</p> <ul style="list-style-type: none"> <li>- Provide barrier linemarking through the intersection to prevent overtaking within the intersection.</li> <li>- Provide additional visual queues (signage, guide posts and intersection linemarking) for the approaching/trailing road users that vehicles are to be turning into or out of the Willigobung Brigade Station access (as well as Willigobung Road).</li> <li>- Provide a clear sightline envelope free of obstructions to ensure intervisibility between approaching vehicles on the through road and the entering vehicles from the Willigobung Brigade Station access.</li> <li>- Provide active signage signage to alert approaching road users that vehicles are to be expected to entering the through road from the Willigobung Brigade Station access.</li> </ul> <p><i>NOTE: due to the nature of this access, greater consideration is needed. Particularly usage during a high pressure emergency scenario.</i></p>	Rare	Moderate	L

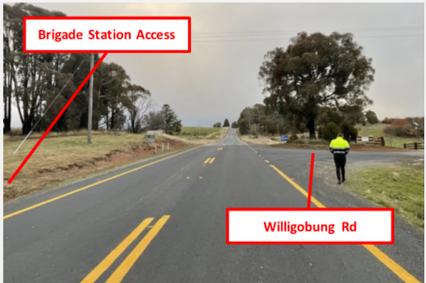
<p>Looking South on Batlow Road towards the intersection/access.</p>	<p>Approaching road users may fail to safely brake or take evasive action should a road user mistakenly enter Batlow Road without an adequate gap in through traffic. This may result in a high-speed intersection crash. The likely travel speeds and impact angles may result in a high energy transfer at impact causing serious harm to occupants.</p> <p><b>NOTES:</b></p> <ul style="list-style-type: none"> <li>- The excessive travel speeds recorded at the site will further reduce the time available for an approaching driver to react and brake.</li> <li>- This hazard will be exacerbated during adverse weather and at night time.</li> </ul>							
		<p><b>LONGER TERM / HIGHER COST</b></p> <p>Implement the recommended actions as shown by <i>Attachment A – Stage 2: Longer Term / Higher Cost Layout</i>:</p> <ul style="list-style-type: none"> <li>- Provide an all weather access to the Willigobung Brigade Stations by realigning the access and installing a storm water culvert.</li> <li>- Provide a basic right turn treatment (BAR) to assist trailing road users to pass a right turning vehicle into the Willigobung Brigade Stations access.</li> </ul>	Rare				Moderate	L

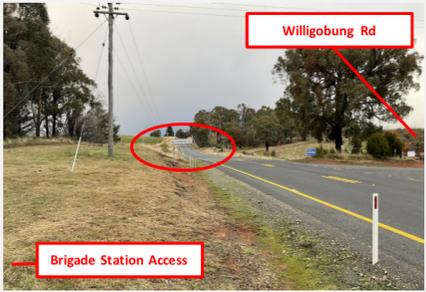
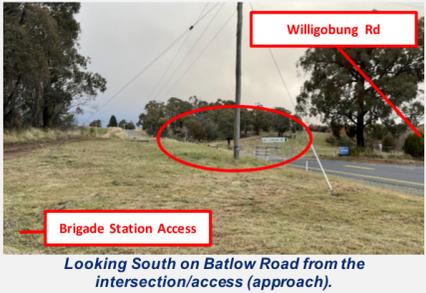
ID	Location	Photos / Reference	Description of Deficiency & Likely Consequence	Likelihood	Severity	Risk Level	Recommended Actions	Likelihood	Severity	Risk Level
ID-3	Sight restriction to the south from the Willigobung Brigade Station access

<p>The Safe Intersection Sight Distance (SISD) from the Willigobung Brigade Station access is restricted by a cut embankment and signage arrangement on the east side of Batlow Road on approach to the hold point.</p> <p>The cut embankment as well as the directional fingerboard signage arrangements restrict sight lines to potential vehicles on the through road and entering traffic from the brigade station.</p> <p>A road user may mistakenly enter Batlow Road without an adequate gap in through traffic and result in a high-speed intersection crash. The likely travel speeds and impact angles may result in a high energy transfer at impact causing serious harm to occupants.</p>	Rare	Serious	M (FSI)	<p><b>SHORTER TERM / LOWER COST</b></p> <p>Implement the recommended actions as shown by <i>Attachment A – Stage 1: Shorter Term / Lower Cost Layout</i>:</p> <ul style="list-style-type: none"> <li>- Provide barrier linemarking through the intersection to prevent overtaking within the intersection.</li> <li>- Provide additional visual cues (signage, guide posts and intersection linemarking) for the approaching/trailing road users that vehicles are to be turning into or out of the Willigobung Brigade Station access (as well as Willigobung Road).</li> <li>- Provide a clear sightline envelope free of obstructions to ensure intervisibility between approaching vehicles on the through road and the entering vehicles from the Willigobung Brigade Station access.</li> <li>- Provide active signage signage to alert approaching road users that vehicles are to be expected to entering the through road from the Willigobung Brigade Station access.</li> </ul> <p><i>NOTE: due to the nature of this access, greater consideration is needed. Particularly usage during a high pressure emergency scenario.</i></p>	Rare	Moderate	L

<p><b>NOTES:</b></p> <ul style="list-style-type: none"> <li>- The excessive travel speeds recorded at the site will further reduce the time available for an approaching driver to react and brake.</li> </ul>

<p><b>LONGER TERM / HIGHER COST</b></p> <p>Implement the recommended actions as shown by <i>Attachment A – Stage 2: Longer Term / Higher Cost Layout</i>:</p> <ul style="list-style-type: none"> <li>- Provide an all weather access to the Willibobung Brigade Stations by realigning the access and installing a storm water culvert.</li> <li>- Provide a basic right turn tratement (BAR) to assit trailing road users to pass a right turning vehicle into the Willibobung Brigade Stations access.</li> </ul>	Rare				Moderate

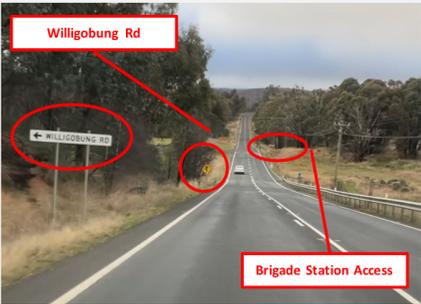
ID	Location	Photos / Reference	Description of Deficiency & Likely Consequence	Likelihood	Severity	Risk Level	Recommended Actions	Likelihood	Severity	Risk Level
ID-4	Northbound Approach to the intersection/access

<p>Looking north on Batlow Road towards the intersection/access.</p>	<p>All visual queues (direction and intersection warning signage) on approach to the northbound approach to the Willigobung Road intersection (left turn) and adjacent Willigobung Brigade Station access (right turn) provide a message provided to trailing vehicle looking to overtake that only a left turn option is available. Should a road user turn on their right turn indicator with the intention of turning into the brigade access, this may be misinterpreted by trailing vehicles as a signal that they can overtake.</p> <p>This may result in high-speed overtaking type crash involving road users travelling northbound on Batlow Road and those entering Willigobung Brigade Station access or an opposing southbound road user travelling on Batlow Road. The likely travel speeds and impact angles may result in a high energy transfer at impact causing serious harm to occupants.</p> <p>NOTES:</p> <ul style="list-style-type: none"> <li>- The excessive travel speeds recorded at the site will further reduce the time available for an approaching driver to react and brake.</li> <li>- This hazard will be exacerbated during adverse weather and at night time.</li> </ul>	Unlikely	Serious	H (FSI)	<p><b>SHORTER TERM / LOWER COST</b></p> <p>Implement the recommended actions as shown by <i>Attachment A – Stage 1: Shorter Term / Lower Cost Layout</i>:</p> <ul style="list-style-type: none"> <li>- Provide barrier linemarking through the intersection to prevent overtaking within the intersection.</li> <li>- Provide additional visual queues (signage, guide posts and intersection linemarking) for the approaching/trailing road users that vehicles are to be turning into or out of the Willigobung Brigade Station access (as well as Willigobung Road).</li> <li>- Provide a clear sightline envelope free of obstructions to ensure intervisibility between approaching vehicles on the through road and the entering vehicles from the Willigobung Brigade Station access.</li> <li>- Provide active signage to alert approaching road users that vehicles are to be expected to entering the through road from the Willigobung Brigade Station access.</li> </ul> <p><i>NOTE: due to the nature of this access, greater consideration is needed. Particularly usage during a high pressure emergency scenario.</i></p>	Unlikely	Moderate	M

<p><b>LONGER TERM / HIGHER COST</b></p> <p>Implement the recommended actions as shown by <i>Attachment A – Stage 2: Longer Term / Higher Cost Layout</i>:</p> <ul style="list-style-type: none"> <li>- Provide an all weather access to the Willigobung Brigade Stations by realigning the access and installing a storm water culvert.</li> <li>- Provide a basic right turn treatment (BAR) to assist trailing road users to pass a right turning vehicle into the Willigobung Brigade Stations access.</li> </ul>			
							<b>RESIDUAL RISK</b>		<b>RESIDUAL RISK</b>

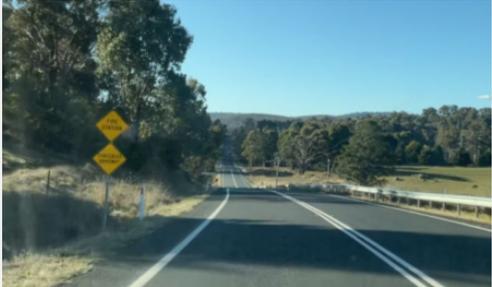
ID	General Observations	Photos / Reference
<p><b>GO-1</b></p>	<p>The recently installed advanced warning signage arrangement includes a W5-36 "Fire Station" sign paired with a W5-55-1n "Concealed Driveway", which may be difficult for a road user to observe, comprehend and react (if required) when travelling at high speeds. Road users must divide their attention between the road alignment, traffic (both oncoming and trailing vehicles that may be seeking to overtake), as well as other signage, delineation devices, and other environmental factors.</p> <p>At high speeds, this division becomes more critical as the consequences of not paying full attention to the road alignment are more severe. This can lead to prioritising road monitoring over reading signs, resulting in missed or misunderstood information. Road users may fail to fully receive the intended warning message and/or ultimately understand the possibility of vehicles entering Batlow Road from a concealed location. This issue may be further exacerbated when the site is subject to inclement weather.</p> <p>NOTE: Warning signage that relies solely on words without graphics can pose significant challenges. These signs can be difficult to read quickly due to language barriers, increased cognitive load, and slower processing times. They are also less visible from a distance and harder to comprehend in poor weather conditions. Additionally, variations in literacy levels further complicate comprehension and issues with readability. In emergencies, the quick and clear communication provided by symbols is crucial for safety. Therefore, using a combination of text and graphics on warning signs is often used to enhance recognition and understanding for a diverse range of drivers.</p>

<p style="text-align: center;"><i>Looking north along Batlow Road towards Willigobung Road intersection and Brigade Station access.</i></p> <div style="text-align: center;">

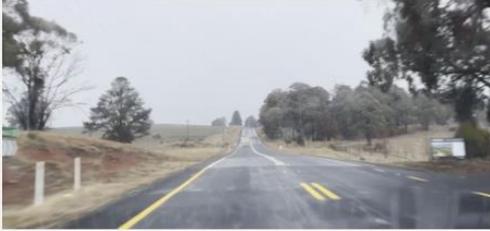
ID	General Observations	Photos / Reference
<p><b>GO-2</b></p>	<p>The transition of yellow to white linemarking occurs approximately 10m south of the Willigobung Road intersection. The linemarking colour transition indicates a likely area for snow and ice. The transition location has not been changed as part of the recent works. Further consideration may be given to relocating the transition to the higher elevation further up the hill, approximately 350m south of the intersection.</p> <p><b>NOTE:</b> The change of linemarking colour may be difficult to implement until there is a need for a reseal.</p>

<p><i>Looking south along Batlow Road from the Willigobung Road intersection and Brigade Station access.</i></p>
<p><b>GO-3</b></p>	<p>At the time of inspection, it was noted that recent roadside vegetation removal had been undertaken to improve visibility along Batlow Road from the Brigade Station access.</p> <p><b>NOTE:</b> This vegetation removal assists in addressing findings contained within the road safety audit RES2305.42.117. Regular maintenance may be required to ensure unrestricted sight lines are retained in the future.</p>

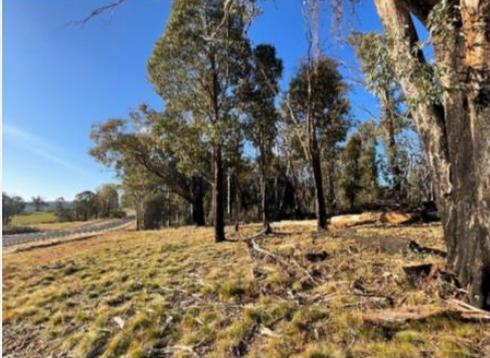
<p><i>Looking north along Batlow Road from the Brigade Station Access</i></p>

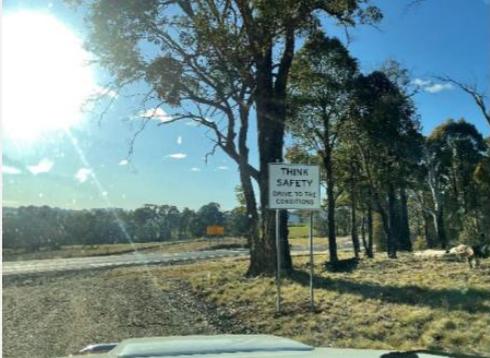
<p><b>GO-4</b></p>	<p>At the time of inspection, it was noted that a sign had been installed to alert those leaving the Brigade Station access to "THINK SAFETY DRIVE TO THE CONDITIONS"</p> <p><b>NOTE:</b> This sign provides a clear message that caution must be taken when entering Batlow Road and assists in addressing findings contained within the road safety audit RES2305.42.117.</p>

<p><i>Looking west at Batlow Road from the Brigade Station Access</i></p>

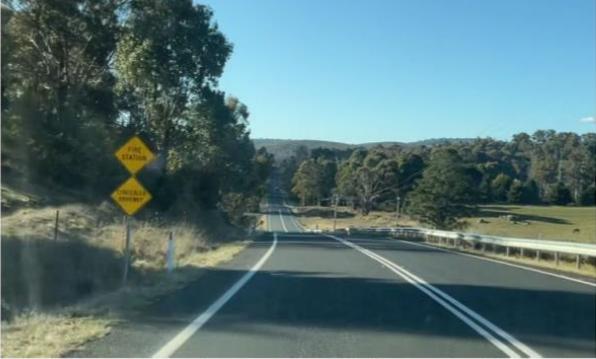
ID	Location	Photos / Reference	Description of Deficiency & Likely Consequence	Likelihood	Severity	Risk Level
ID-1	Northbound warning signage arrangement (~300m south of the intersection)

<p>Looking north along Batlow Road towards Willigobung Road intersection and Brigade Station access.</p>

<p>W5-36 "Fire Station" W5-55-1n "Concealed Driveway"</p>	<p>The recent works involved the installation of W5-36 "Fire Station" paired with W5-55-1n "Concealed Driveway" warning signs. The advanced warning signage arrangement has been installed on the inside of a horizontal curve on the crest approximately 300m south of the intersection with Willigobung Road/Brigade Station access.</p> <p>However, should a northbound road user fail to observe, comprehend and react when required (refer to GO-1 above), it may result in high-speed intersection crash types involving road users travelling northbound on Batlow Road and those entering/exiting the Willigobung Brigade Station access. The likely travel speeds and impact angles may result in a high energy transfer at impact causing serious harm to occupants.</p> <p>Should a road user's attention be taken away from the roadway at a critical time on the approach to a substandard horizontal curve and vertical crest curve, this may cause drivers to stray outside the dedicated travel lane into oncoming traffic, resulting in head-on type collision at high speeds.</p> <p>NOTES: This hazard will be exacerbated during adverse weather and at nighttime when visibility is reduced.</p>	Rare	Serious	Medium (FSI)

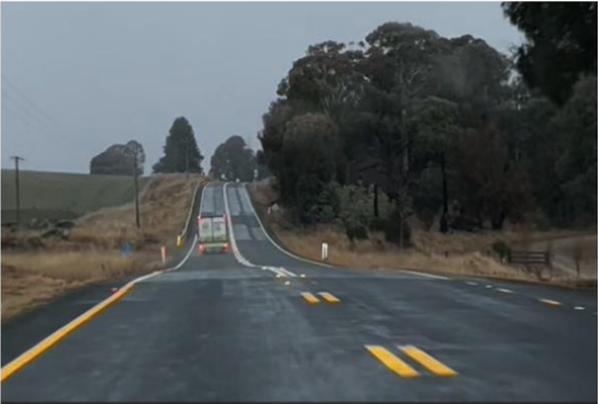
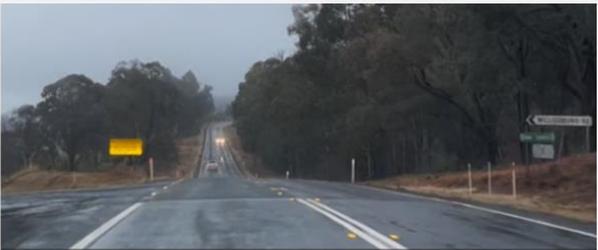
ID	Location	Photos / Reference	Description of Deficiency & Likely Consequence	Likelihood	Severity	Risk Level
ID-2	Central barrier linemarking for the intersection/access

<p><i>Looking south on Batlow Rd at the Willigobung Rd Intersection</i></p>

<p><i>Looking north on Batlow Rd at the Willigobung Rd Intersection</i></p>	<p>The recent works involved the extension of central double barrier linemarking from the crest south of the Willigobung Road intersection to the transition between white and yellow linemarking about 10m south of the intersection with Willigobung Road/Brigade Station access. This will assist in preventing northbound overtaking through the intersection. However, there is no leading central barrier linemarking (tail) on the southbound approach to the Willigobung Road intersection restricting overtaking manoeuvres in the opposing southbound direction. Additionally, Approach Sight Distance (ASD) is not achieved at the commencement of the double barrier line for southbound road users on approach.</p> <p>Should southbound road users commence overtaking before the intersection they may not complete the manoeuvre before the intersection, exposing road users turning left from Willigobung Road (having only checked to their right) to an oncoming overtaking vehicle travelling in the southbound lane.</p> <p>This may result in a high-speed head-on/intersection-type crash. The likely travel speeds and impact angles may result in a high energy transfer at impact causing serious harm to occupants.</p>	Rare	Serious	Medium (FSI)

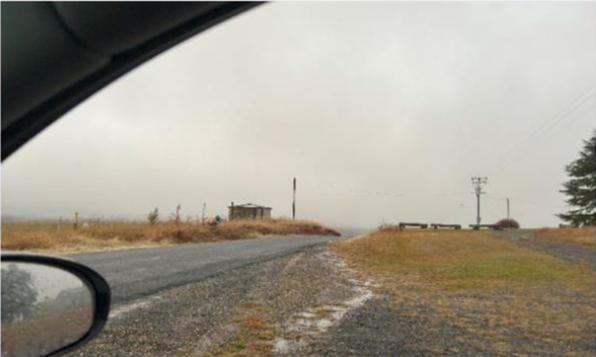
<p>Looking east on Willigobung Rd from the proposed access</p>	<p>The Safe Intersection Sight Distance (SISD) from the proposed Willigobung Brigade Station access is restricted by a tight crest vertical curve and cut embankment obscuring approaching vehicles from the east (looking right).</p>	Unlikely	Moderate	Medium

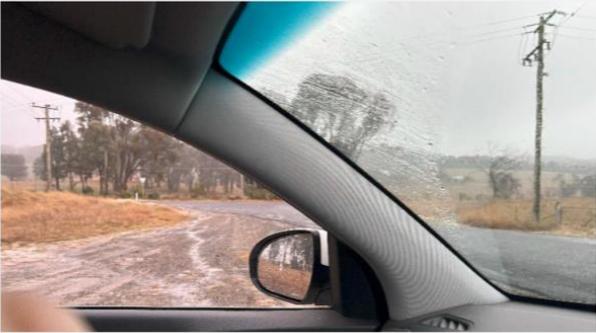
<p>Looking west on Willigobung Rd from the proposed access</p>	<p>The Safe Intersection Sight Distance (SISD) from the proposed Willigobung Brigade Station access is also obstructed by a vehicle's primary support column due to the horizontal geometry of Willigobund Road, obscuring approaching vehicles from the west (looking left).</p> <p>A driver may mistakenly enter Willigobung Road without an adequate gap in through traffic and result in an intersection crash at low to moderate speed. The likely operating speed (50-60km/h) and impact angles may result in a high enough energy transfer at impact to cause a moderate level of harm to occupants.</p> <p>NOTE: The degree of harm may increase should a more vulnerable road user be involved in the collision (e.g. motorcyclist). The degree of harm may be reduced during adverse weather when drivers reduce their operating speed. The likelihood will likely reduce when headlights are being used providing further visual cues of approaching vehicles (e.g. nighttime/fog).</p>

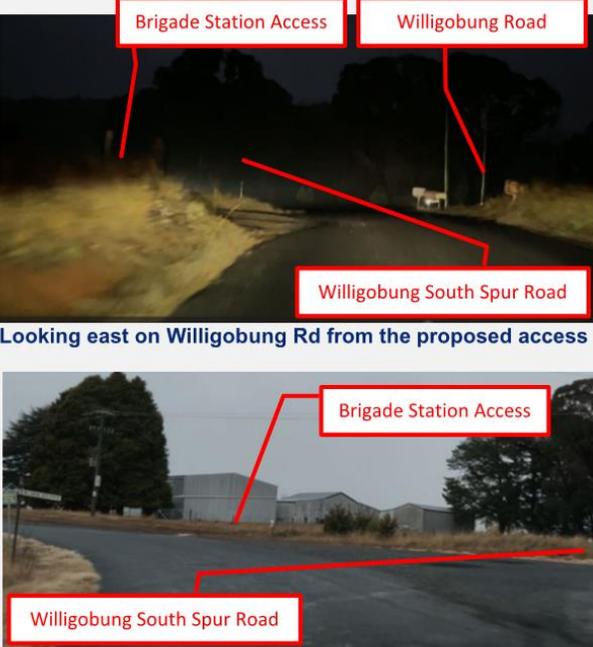
<p>Looking east on Willigobung Rd from the proposed access</p> <p>Looking east on Willigobung Rd from the proposed access</p>	<p>There is a general lack of existing pavement marking and delineation devices along Willigobung Road on both approaches to the proposed brigade station access. Road users were observed to track across the centre of the sealed area when travelling through the horizontal curve on Willigobung Road. This is presumable due to the absence of edge lines and central barrier linemarking to guide lane discipline.</p> <p>A driver may enter Willigobung Road from the proposed Willigobung Brigade Station access whilst an approaching vehicle is tracking across the centre of the sealed area. Should this occur, it will result in an intersection type crash at low to moderate speed. The likely operating speed (50-60km/h) and impact angles may result in a high enough energy transfer at impact to cause a moderate level of harm to occupants.</p> <p>NOTE: The degree of harm may increase should a more vulnerable road user be involved in the collision (e.g. motorcyclist). The degree of harm may be reduced during adverse weather when drivers reduce their operating speed. The likelihood will likely reduce when headlights are being used providing further visual cues of approaching vehicles (e.g. nighttime/fog).</p>	Rare	Moderate	Low
