PRELIMINARY SITE INVESTIGATION

Former Batlow Cannery

1 Leaburn Avenue,

February 2021

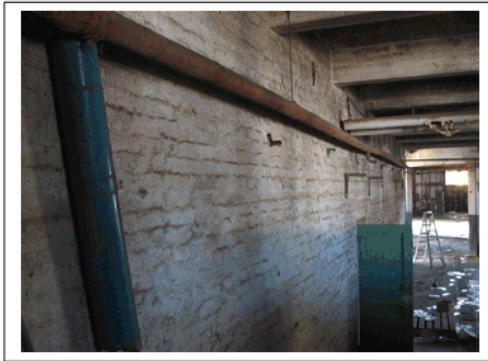
Plate 1 : Pipe lagging to 'Old' Hot water pipe in C & D Building (western side).

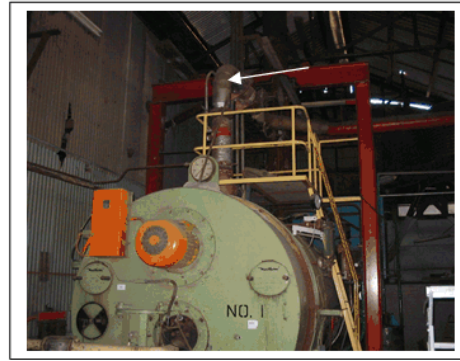
Plate 2 : Pipe Lagging to elbow above Boiler No.1 in Boiler House

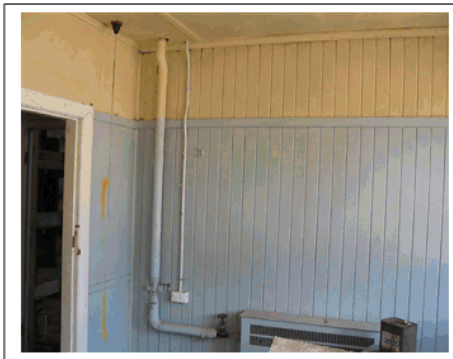
Plate 3 : Pipe Lagging to Hot water pipe in south west office of the C & D Building

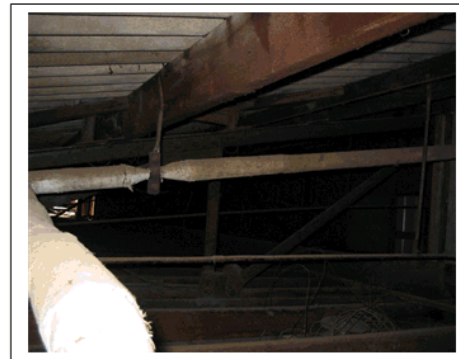
Plate 4 : Pipe Lagging in roof space of the South Offices of the C & D Building

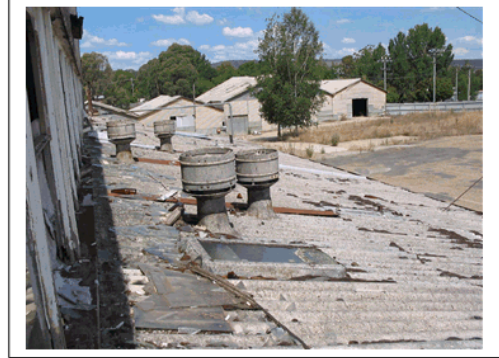
Plate 6: C & D Building: Asbestos Corrugated Roof Sheet, South end.

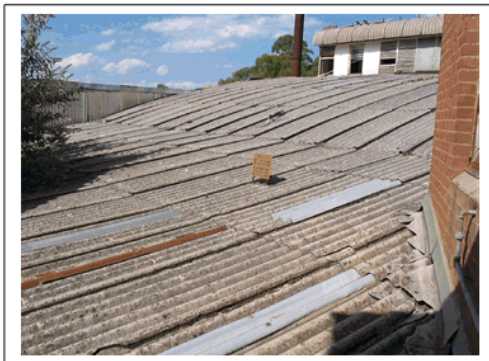
Plate 7: C & D Building: Asbestos Corrugated Roof Sheet from the Loft

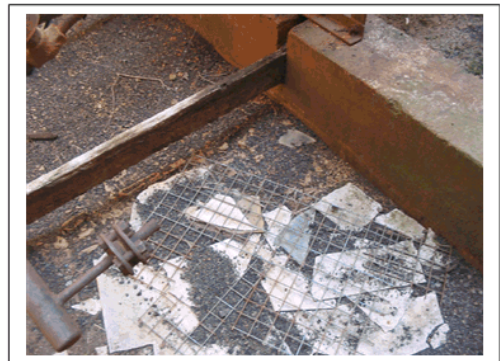
Plate 8: Asbestos Sheet Debris

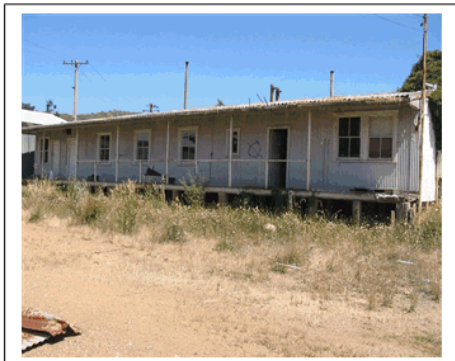
Plate 17 : Display Centre – Verandah Woodwork (**Sample Pb1**: 3.4% - Lead Paint).

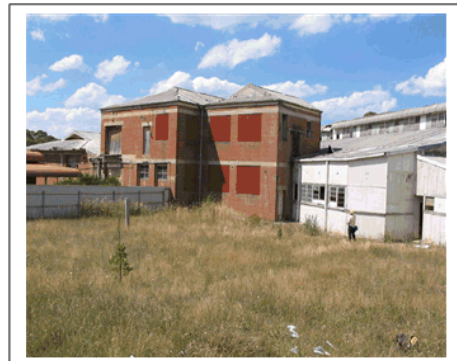
Plate 18 : View of C & D Building to the North – shows low paint use on asbestos cement sheet.

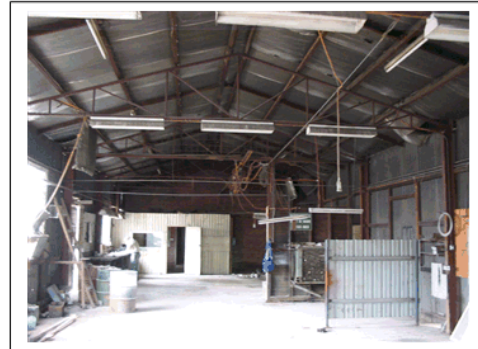
Plate 20 : Assume Fibre glass insulation to roof in Cannery Building

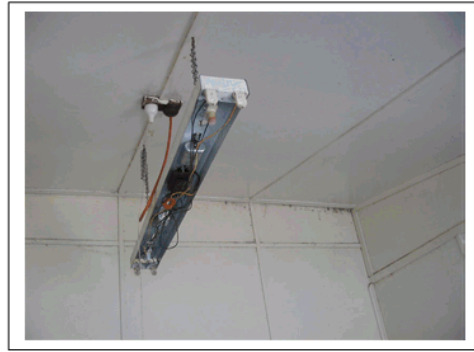
Plate 22 : PCB Capacitor Light Fitting in the Display Centre

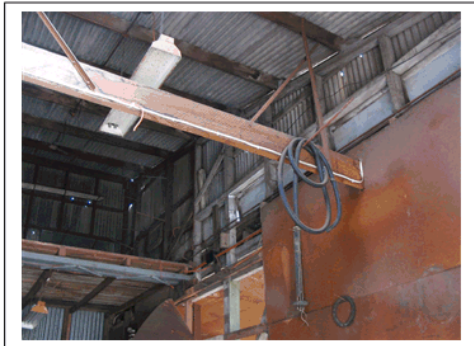
Plate 23 : Assumed PCB Capacitor Light Fitting in C & D Building

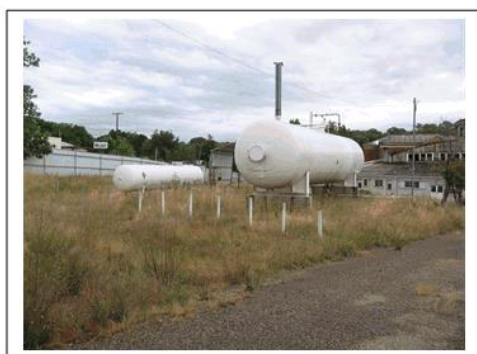
Plate 32 . LPG Gas Storage South of C & D Building

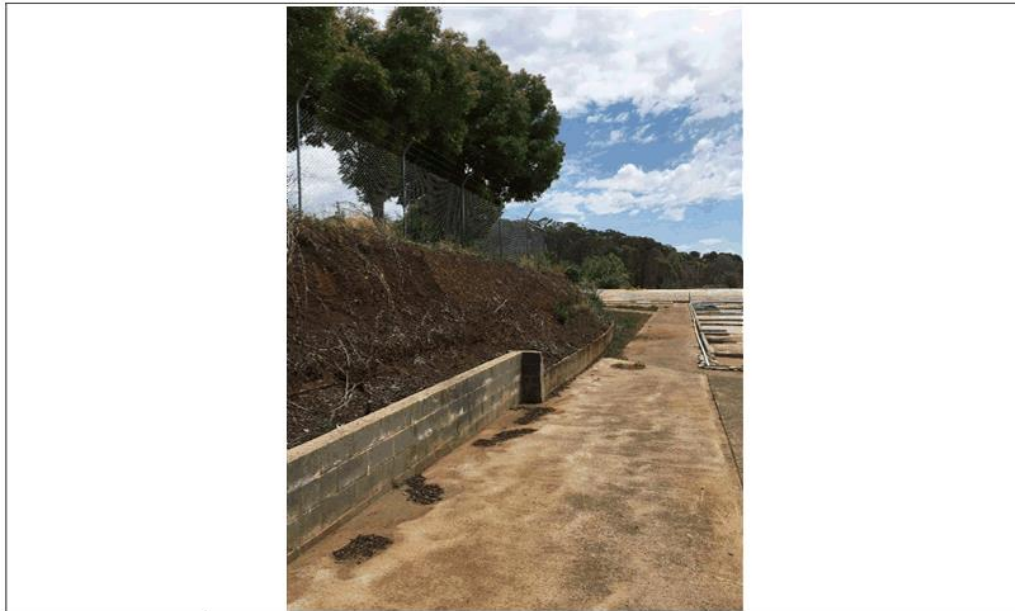
Photograph 15
Date: 1/12/2020 Evidence of cutting into natural soil to level the site along the west boundary of the site. View to the north.

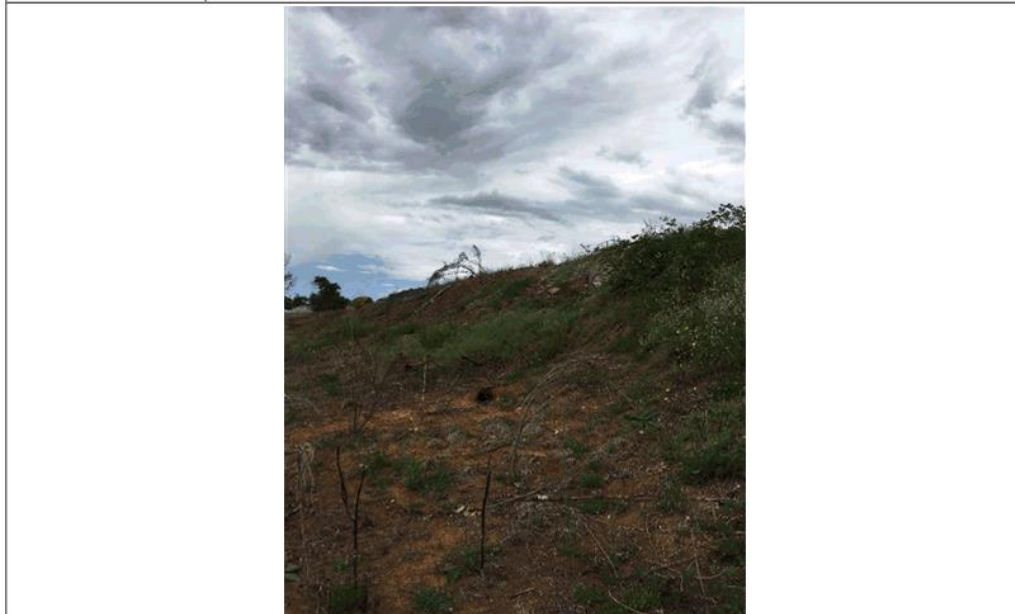
Photograph 16
Date: 1/12/2020 Evidence of backfilling to level site along the east boundary of the site. View to the southwest.

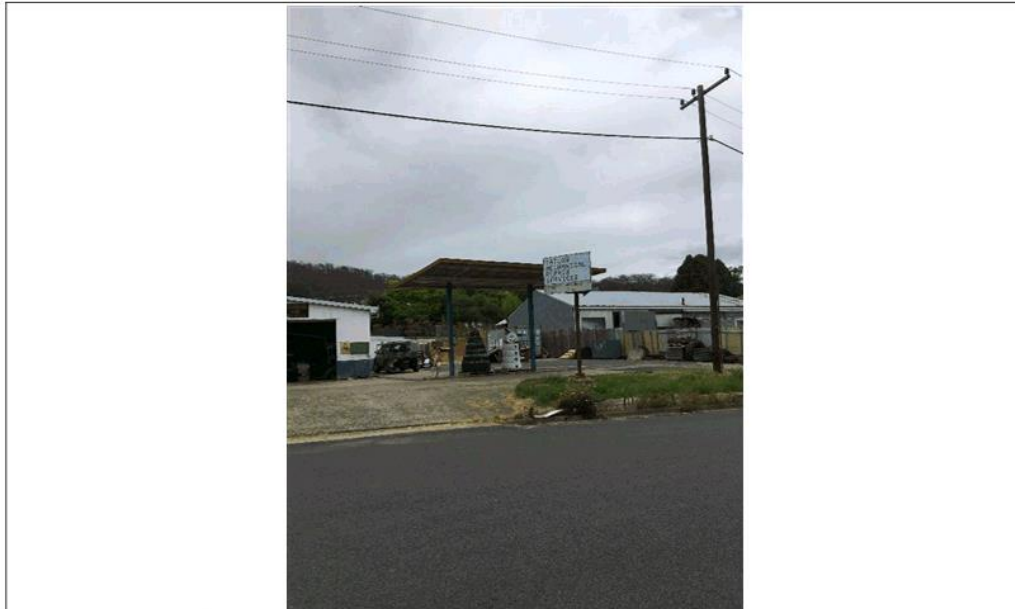
Photograph 19
Date: 1/12/2020
AEC 3 General view of offsite industrial areas located to the west of the site upgradient. View to the west.

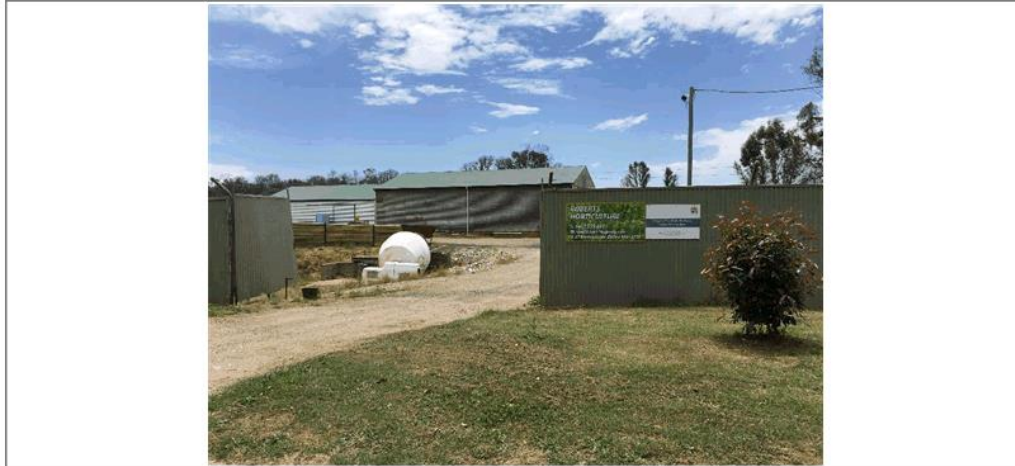
Photograph 20
Date: 1/12/2020
General view of offsite industrial areas located to the east of the site. View to the north.
