## **11.6 WILLIGOBUNG FIRE SHED - ATTACHMENTS**

**NSW Rural Fire Service  
Willigobung Brigade Station**

**Recommendations Report**

**RES2305.42.117**

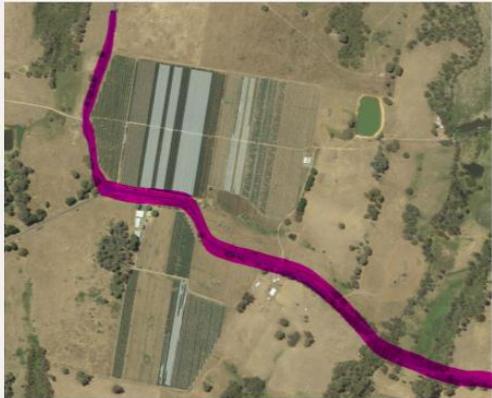
ID	General Observations	Photos / Reference
<b>GO-1</b>	<p>It is noted that the default speed zone for Willigobung Road and Willigobung South Spur Road is 100km/h. Considering the substandard horizontal and vertical geometry, narrow formation width and lack of linemarking and delineation on either side of the proposed access, drivers observed were operating at a speed closer to 50-60km/h.</p> <p><b>NOTE:</b> This self-enforcing environment was observed during both site inspections with drivers further reducing their speed during adverse weather and at night time.</p>
