PRELIMINARY SITE INVESTIGATION

Former Batlow Cannery

1 Leaburn Avenue,

February 2021

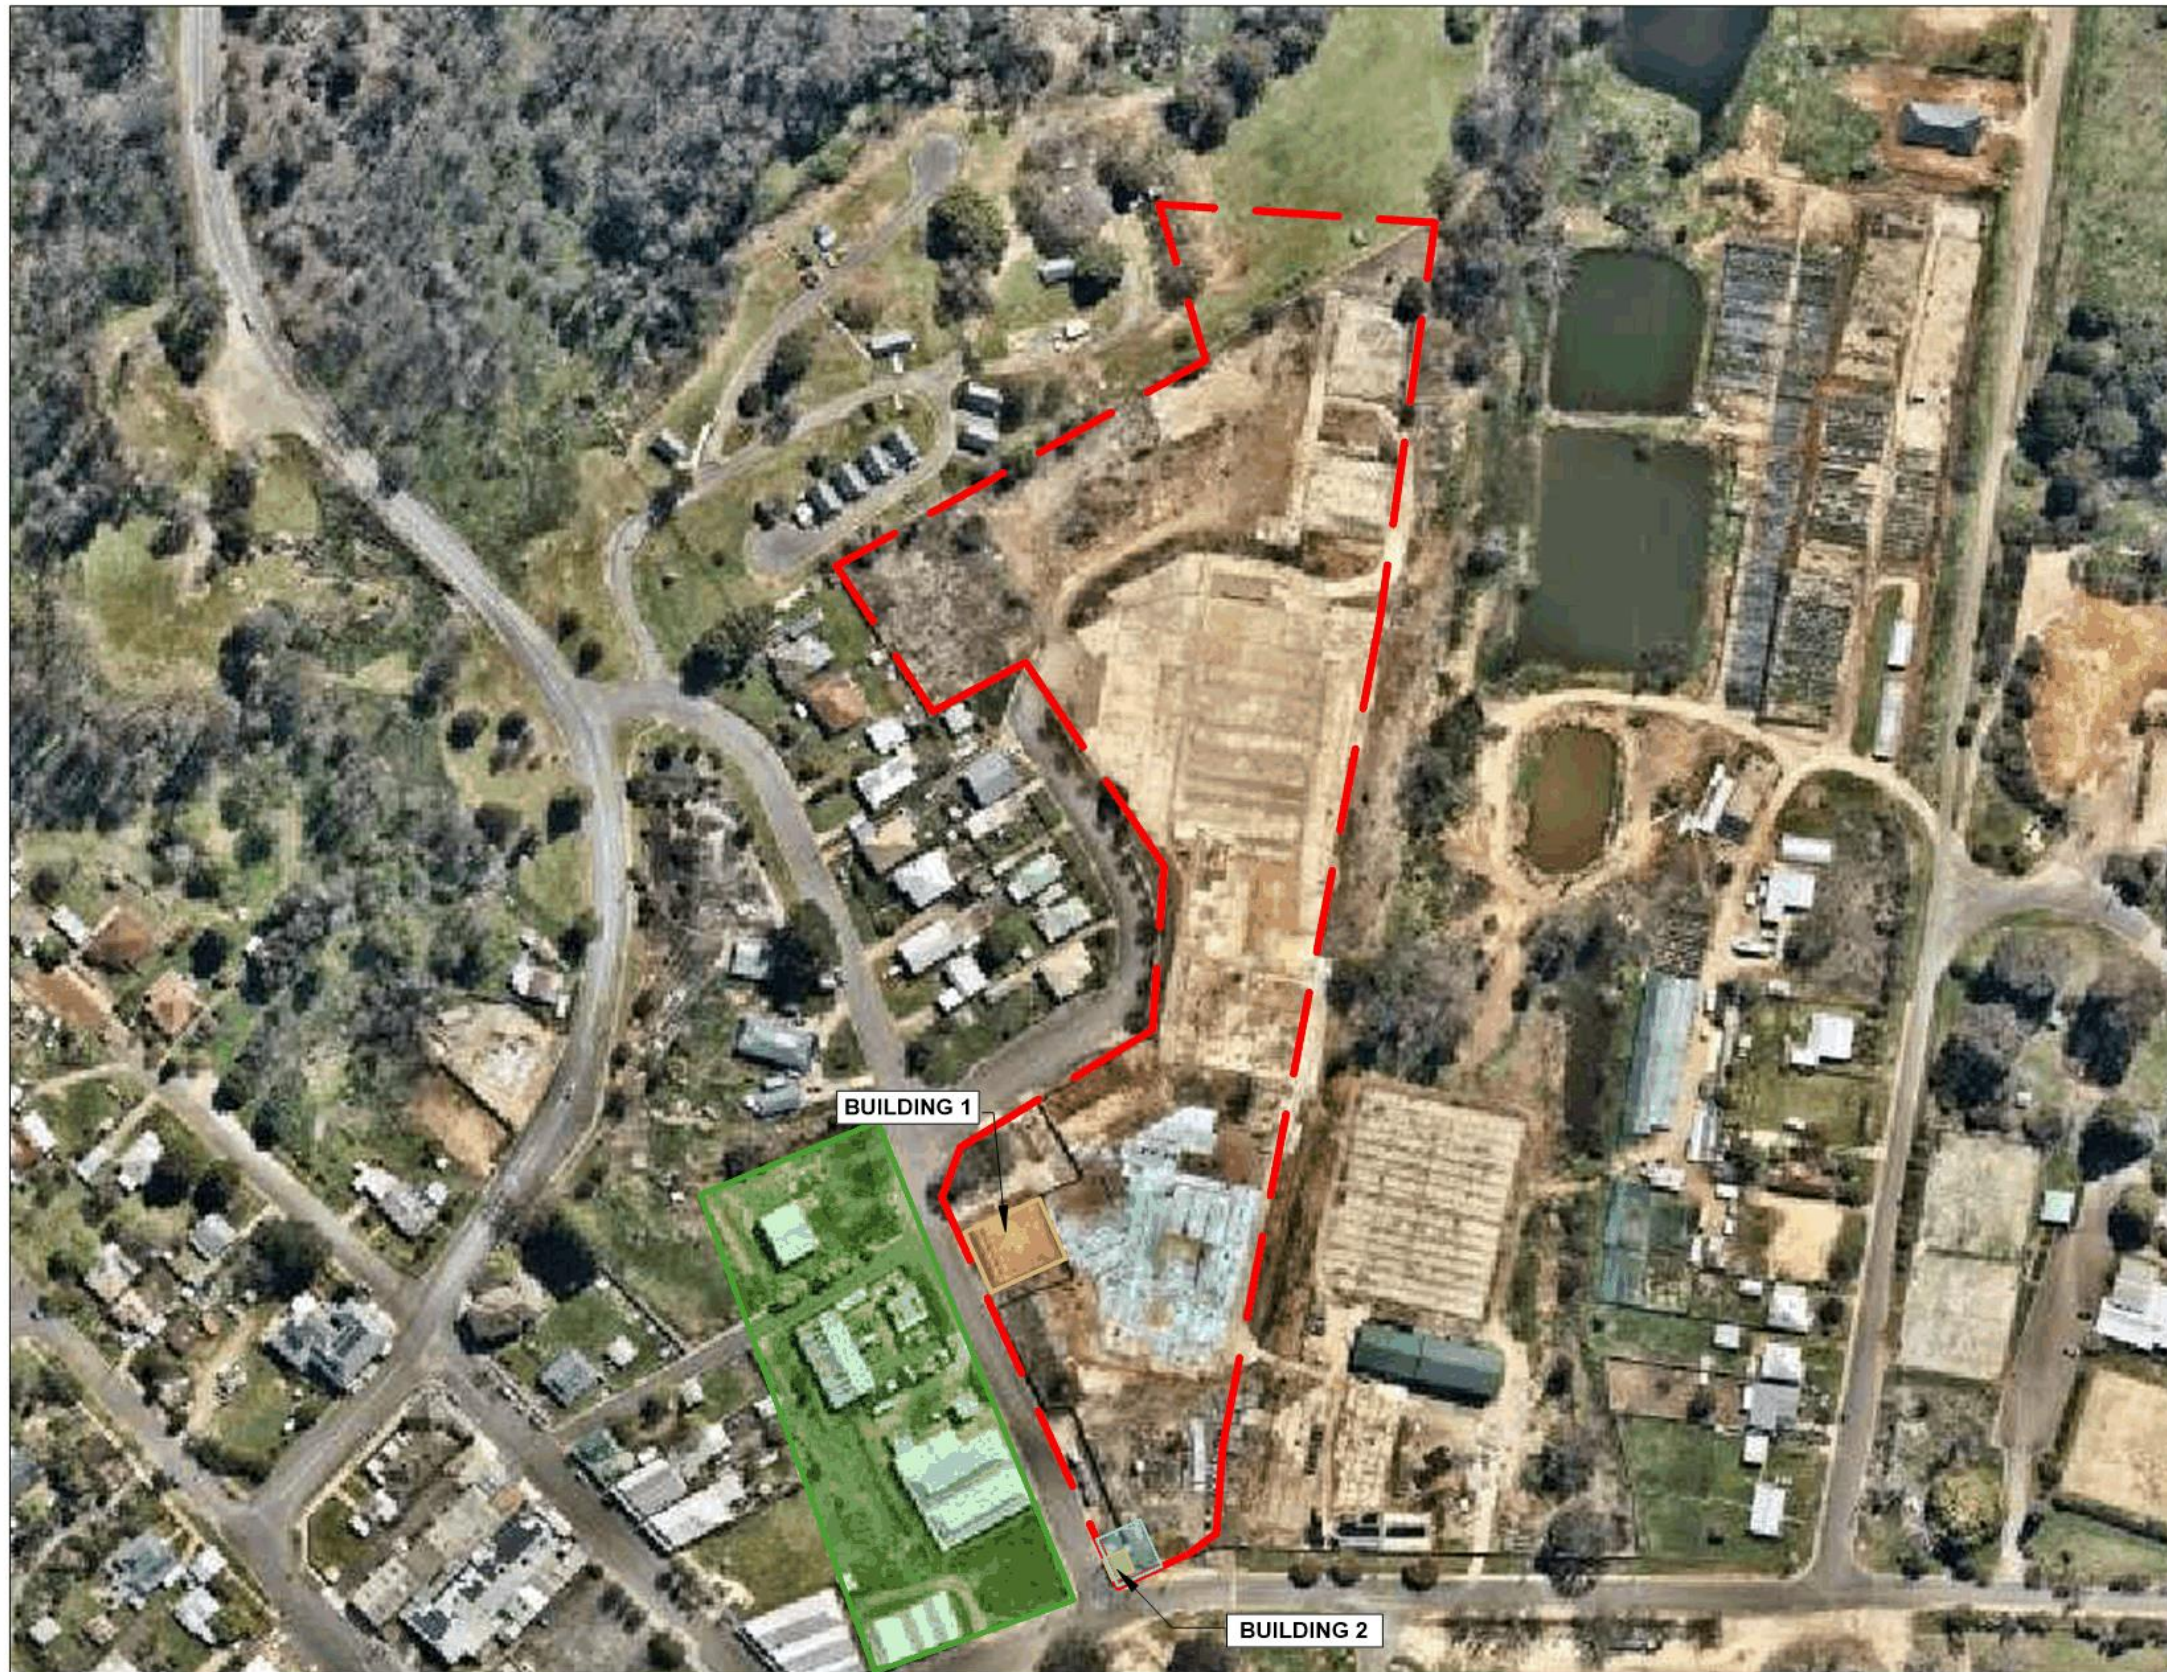
- SITE BOUNDARY (AEC 1 - WHOLE SITE)
- BUILDING 2 (AEC 2)
- OFFSITE INDUSTRIAL AREA (AEC 3)
- ONSITE BUILDINGS 1 AND 2

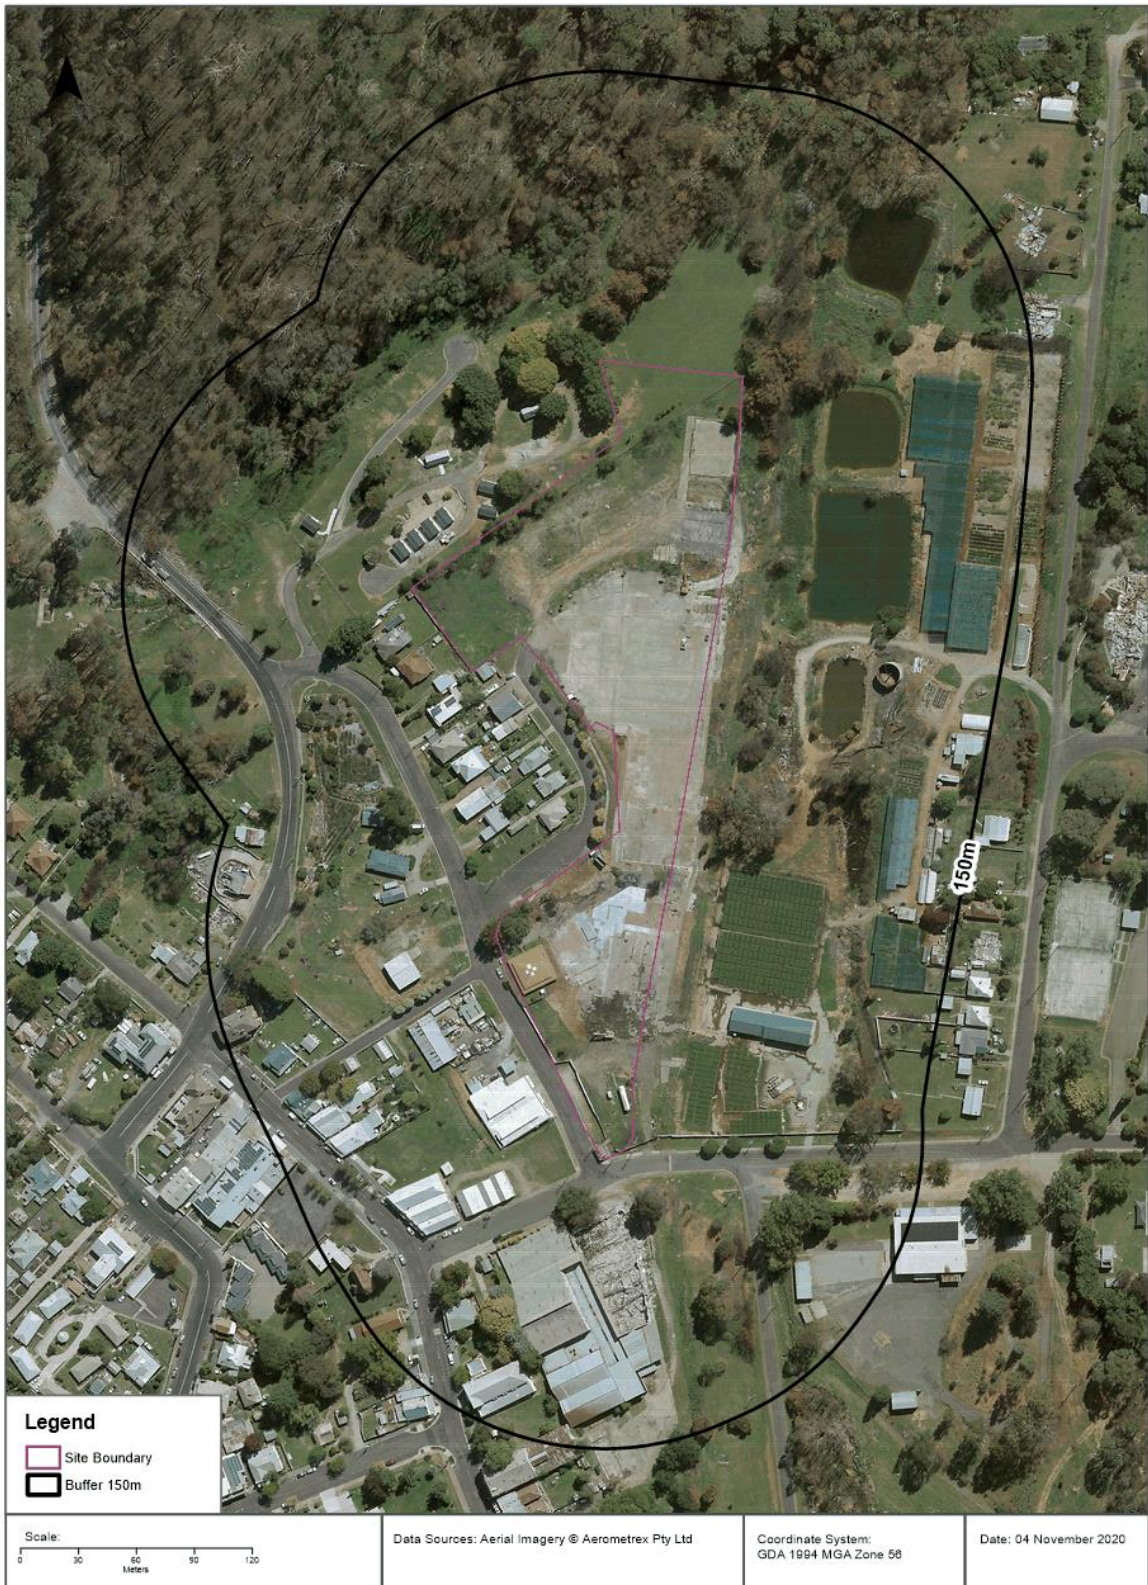
Aerial Imagery 2020
Leaburn Avenue, Batlow, NSW 2730

2019 (Google)	<p>Site: No significant changes are observed from the previous photograph.</p> <p>Surrounding: Additional structures have been installed at the nursery east of the site.</p>
2020 (Aerometrex)	<p>Site: All structures on site have been removed, leaving the concrete slab bases on site. One structure remains on site and an AST in the southern section of the site remains.</p> <p>Surrounding: Permanent structures of the caravan park have been demolished and new buildings constructed in this area. Additional structures have been installed at the nursery east of the site.</p>

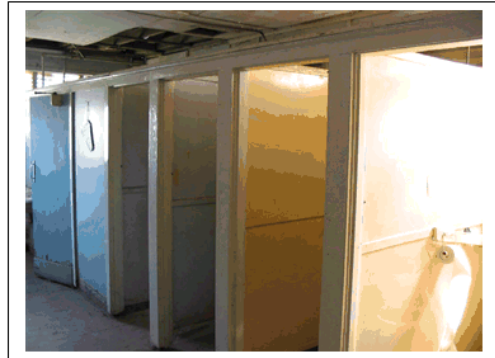
Plate 12: Cannery – West Offices – Asbestos Partitions to toilets

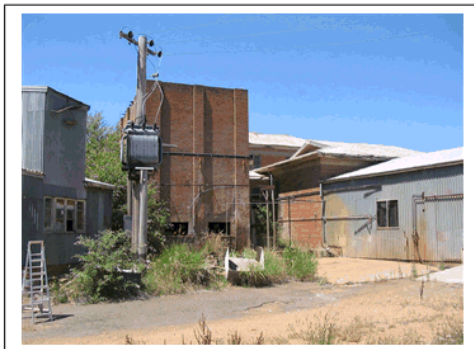
Plate 24. Transformer adjacent Electrical Workshop

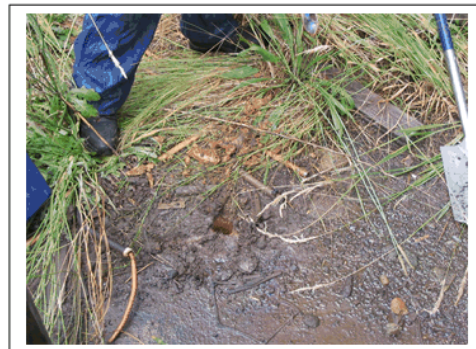
Plate 25. Hydrocarbon Contaminated Soil below the Transformer

However at the time of redevelopment these soils should be excavated, stockpiled and bioremediated on site until the hydrocarbon contamination levels are below 1000mg/Kg (Assessment Criteria i.e. suitable for on-site use).

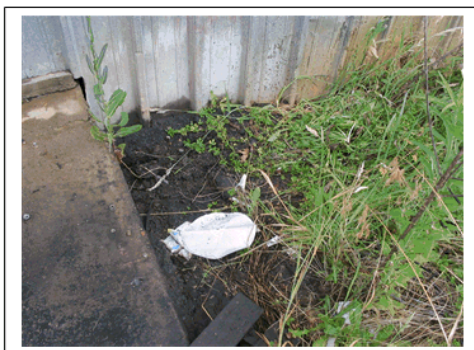
Plate 26. Hydrocarbon Contaminated Soil adjacent the Air Compressor on the Eastern side of the Cannery

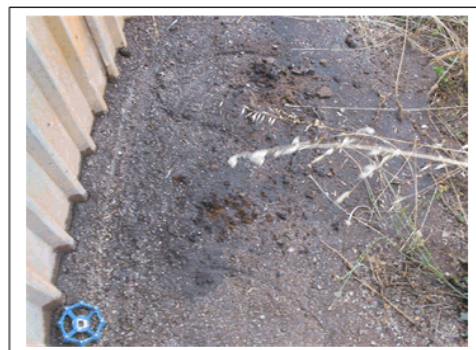
Plates 27. Hydrocarbon Contaminated Soil adjacent the Engine Room on the Eastern side of the Cannery

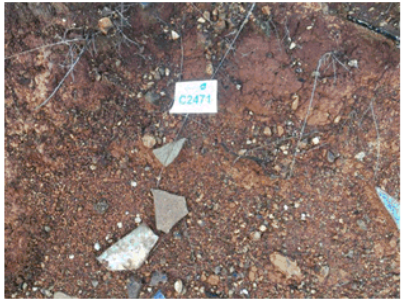
ASBESTOS - Batlow Cannery				
SAMPLE NO.	TRACKER LOCATION NO.	LOCATIONS	MATERIAL DESCRIPTION	PHOTOGRAPH
C2471	N/A	Exterior south garden bed adjacent AST	Sheet debris (Non-Friable)

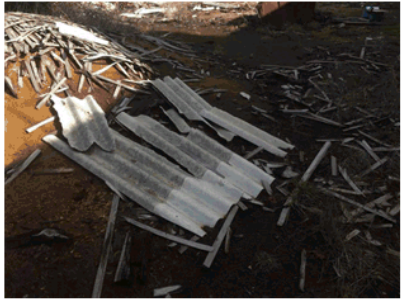
RA C2471	N/A	Exterior northwest end throughout - Ground surfaces	Sheet debris (Non-Friable)

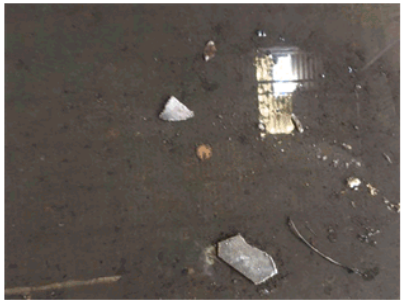
RA L1919	N/A	Ground floor open warehouse - Ground surfaces	Sheet debris (Non-Friable)

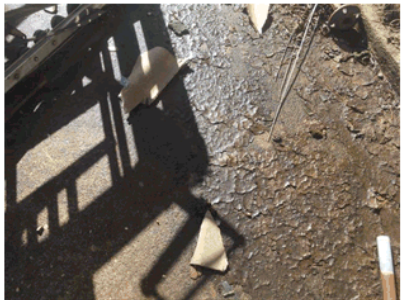
RA L1919	N/A	Exterior west ramp area - Ground surface	Sheet debris (Non-Friable)

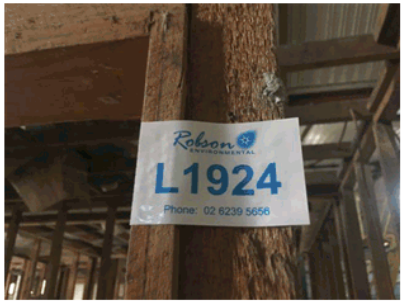
L1924	N/A	Ground floor Chemical Laboratory and Amenities Room - Residual nails on timber stud	Sheet debris (Non-Friable)

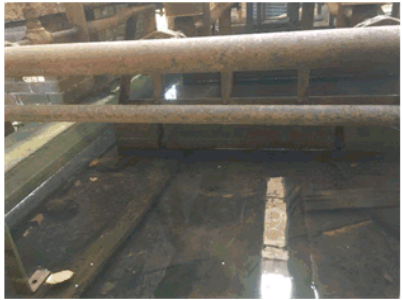
ASBESTOS - Collating and Dispatch				
SAMPLE NO.	TRACKER LOCATION NO.	LOCATIONS	MATERIAL DESCRIPTION	PHOTOGRAPH
	N/A	Ground floor Condenser Room - Ground surface	No Access to Sheet debris (Presumed)

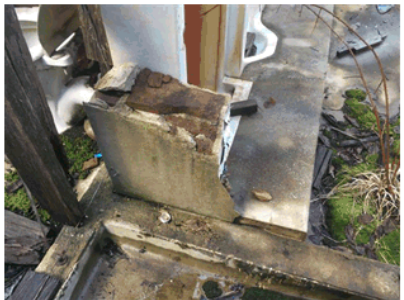
RA C2471	N/A	Ground floor office's toilet area - Urinal wall form work infill panel	Sheet (Non-Friable)

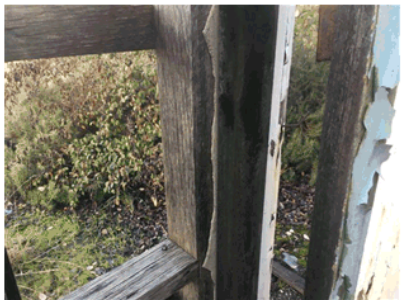
RA C2471	N/A	Ground floor offices - External doorway to toilets area	Sheet (Non-Friable)

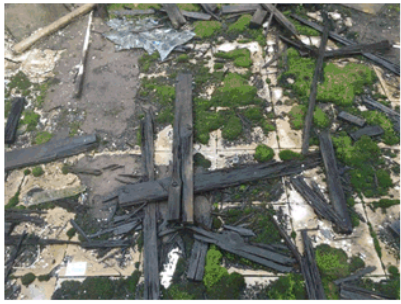
L1900	N/A	Ground floor offices - Floor	Vinyl floor tile (Non-Friable)

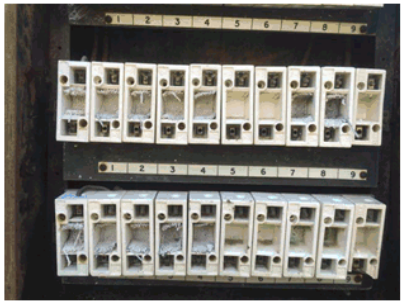
L1908	N/A	Ground floor open warehouse east end - Electrical switchboard fuse insulation	Millboard (Friable)

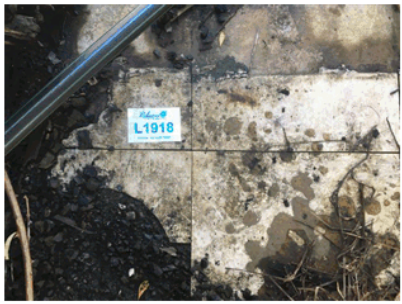
L1918	N/A	Ground floor Carpenter's Workshop - Floor near entrance	Vinyl floor tile (Non-Friable)

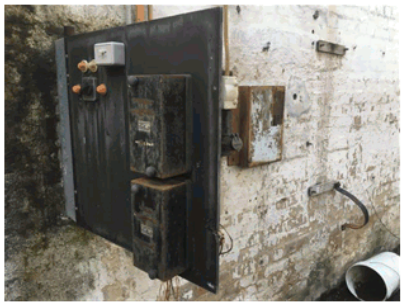
VA01	N/A	Ground floor Ammonia Engine room - Electrical switchboard	Bituminous product (Non-Friable)

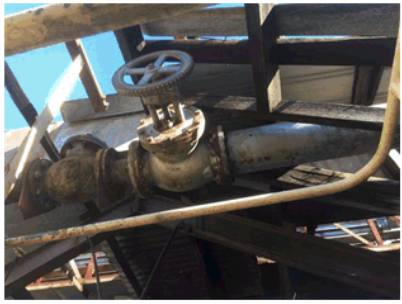
VA03	N/A	Ground floor boiler room - Flange joints	Gaskets (compressed) (Presumed Non-Friable)

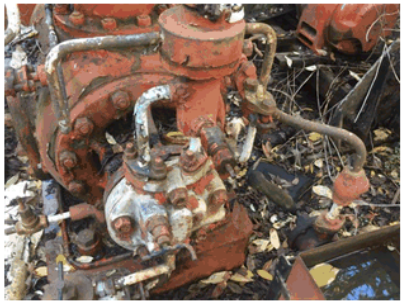
VA07	N/A	Ground floor Ammonia Engine room - Valve packing	Gaskets (compressed) (Presumed Non-Friable)

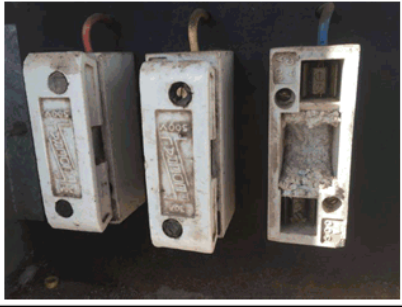
ASBESTOS - Cool Stores				
SAMPLE NO.	TRACKER LOCATION NO.	LOCATIONS	MATERIAL DESCRIPTION	PHOTOGRAPH
RA L1908	N/A	Exterior south end - Fuse insulation	Millboard (Friable)

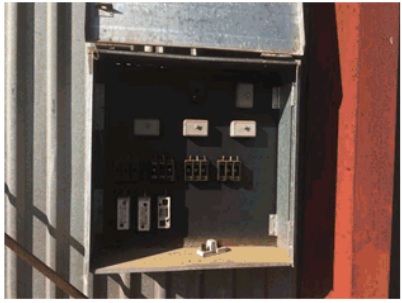
VA05	N/A	Exterior south end - Electrical switchboard	Bituminous product (Presumed Non-Friable)

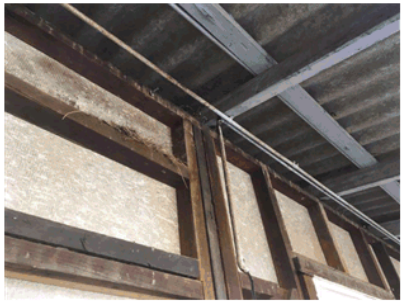
L1930	N/A	Ground floor throughout - Walls, ceiling and roof	Cement sheet (Non-Friable)

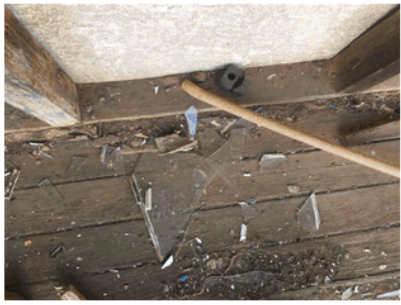
RA L1930	N/A	Ground floor throughout - Ground surfaces	Sheet debris (Non-Friable)

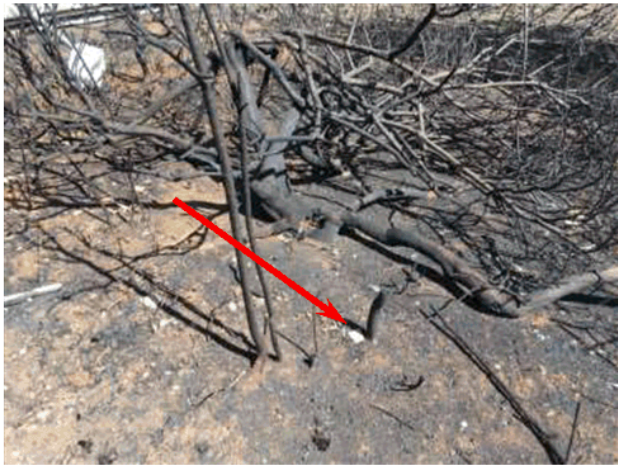
Sample Number	Location (refer Plan)	Material	Photographs
Visually assessed 1	Adjacent southern entry gate side fence	Sheeting fragment

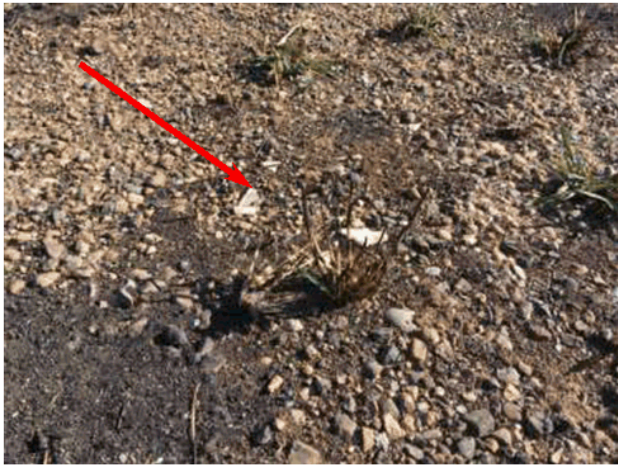
Visually assessed 2	Adjacent soil sample 3	Sheeting fragment

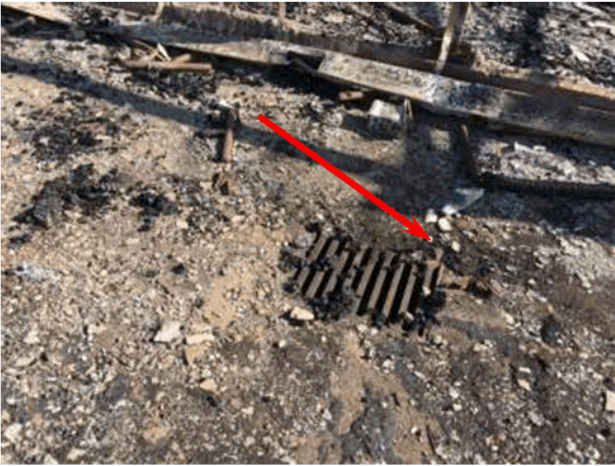
Visually assessed 4	Adjacent formwork to building opposite soil sample 4	Sheeting fragment

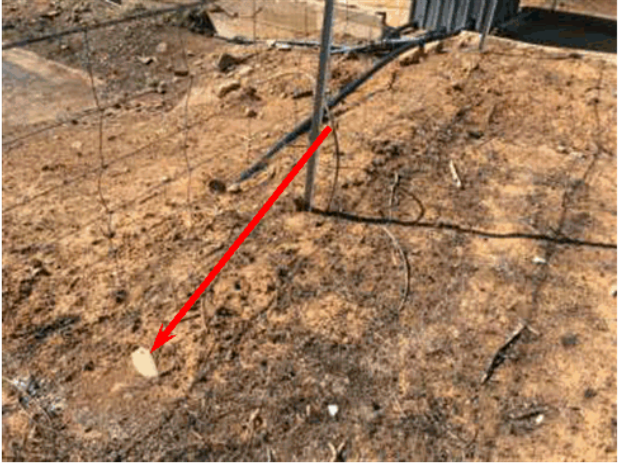
Sample Number	Location (refer Plan)	Material	Photographs
Visually assessed 7	Adjacent soil sample 5	Sheeting fragment

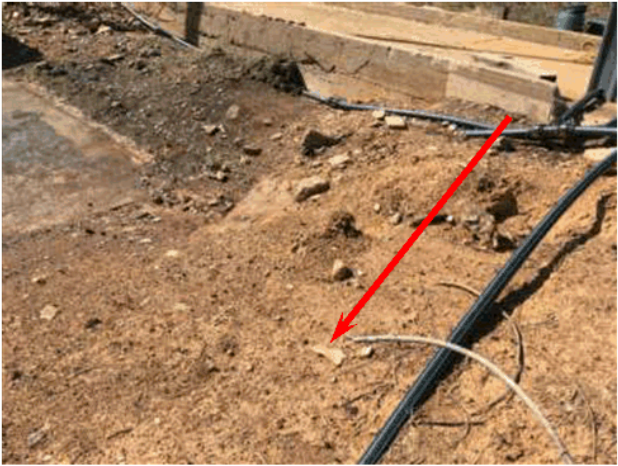
Visually assessed 8	Adjacent soil sample 5 on adjoining Nursery property	Sheeting fragment

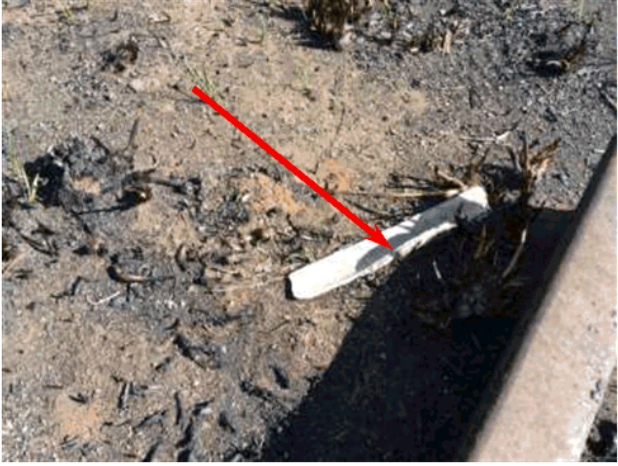
Sample Number	Location (refer Plan)	Material	Photographs
Visually assessed 9	Adjacent soil sample 6 and railway line	Sheeting fragment

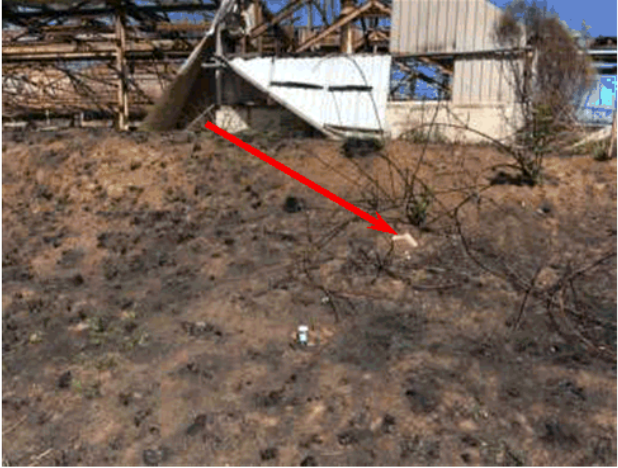
Sample Number	Location (refer Plan)	Material	Photographs
Visually assessed 13	Adjacent soil sample 10	Sheeting fragment

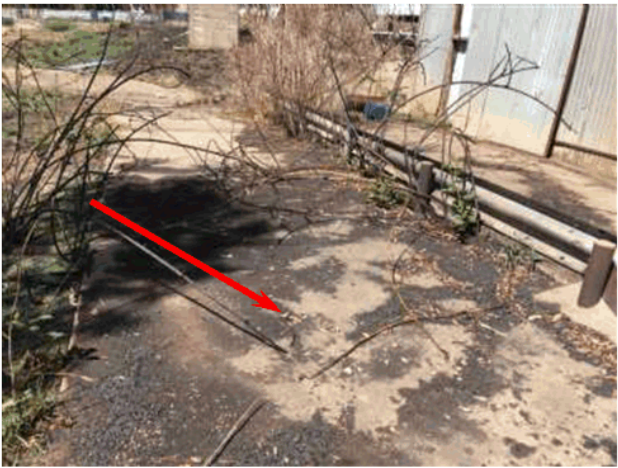
Visually assessed 14	Adjacent soil sample 12 on concrete slab	Sheeting fragment

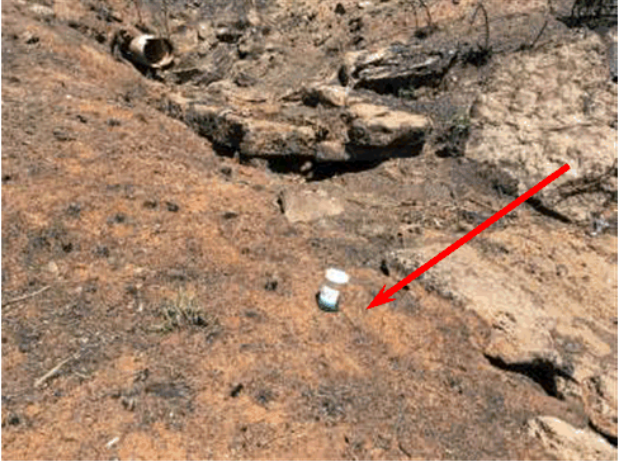
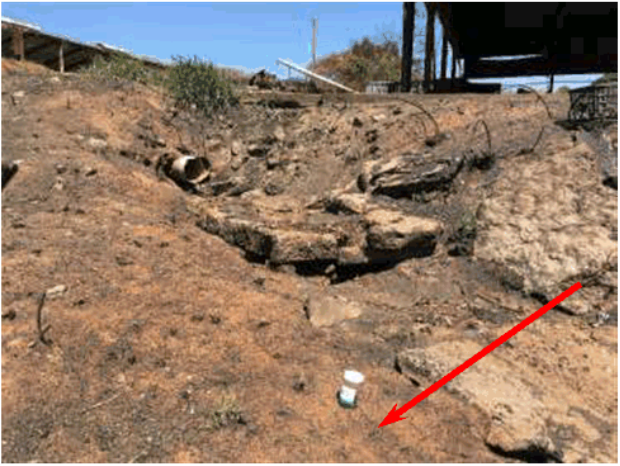
Sample Number	Location (refer Plan)	Material	Photographs
864002 - 16	Building H 5m n/e of fire damaged stormwater pipe	Soil - top 10cm

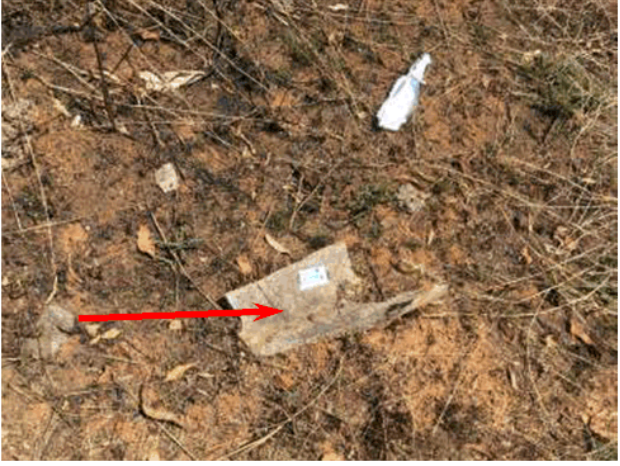
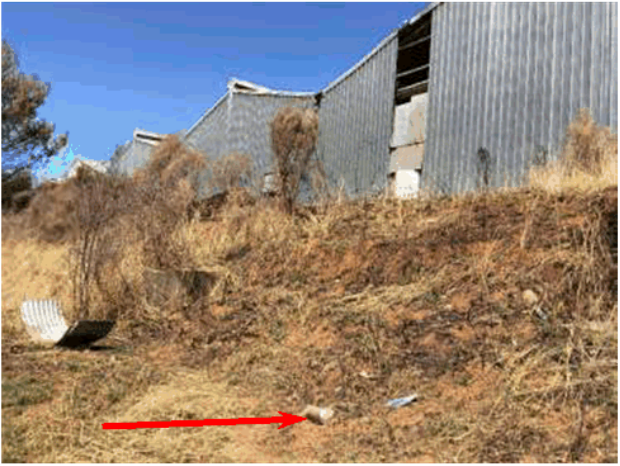
Sample Number	Location (refer Plan)	Material	Photographs
L2376	Surface soil fragment 10 metres east of Building B (4th peak from southern end)	Pipe section

L2376	Surface soil fragment 10 metres east of Building B (4th peak from southern end)	Pipe section

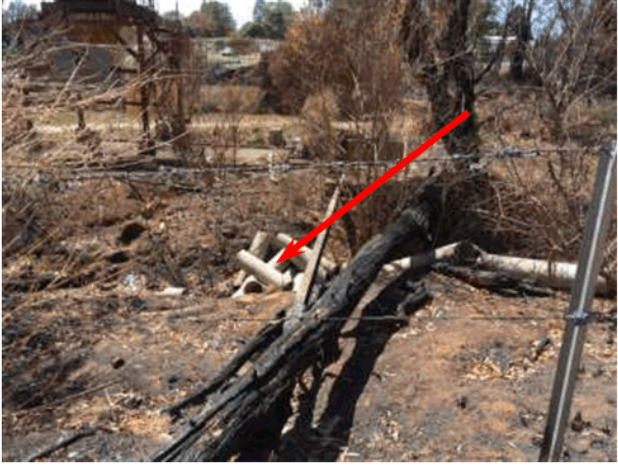
Sample Number	Location (refer Plan)	Material	Photographs
Consistent with Sample L2376	ACM pipe sections on adjoining property	Pipe sections

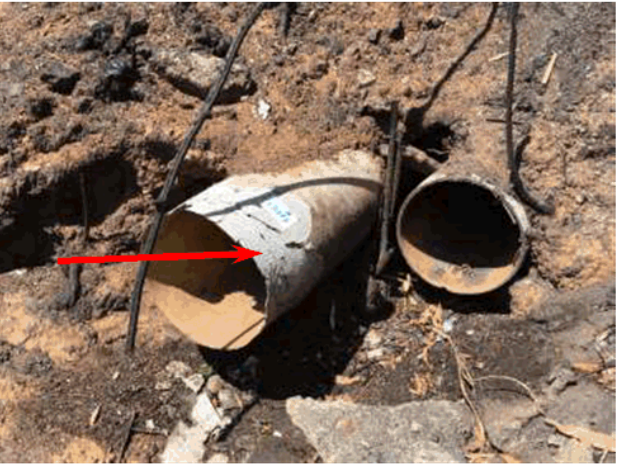
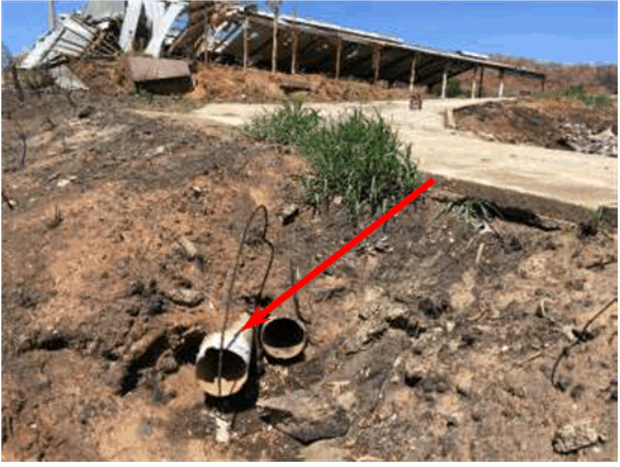
L2377	Stormwater pipe debris east of s/e corner of Building	Pipe section

Sample Number	Location (refer Plan)	Material	Photographs
L2377	Stormwater pipe debris east of s/e corner of Building	Pipe section

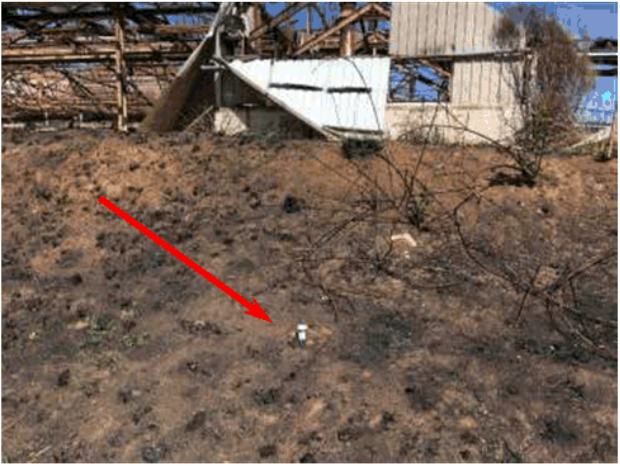
Sample Number	Locations (as per Plan)	Material	Photographs
864002 - 10	Building A 10m east & 54m north of s/e corner	Soil - top 10cm

864002 - 10	Building A 10m east & 54m north of s/e corner	Soil - top 10cm

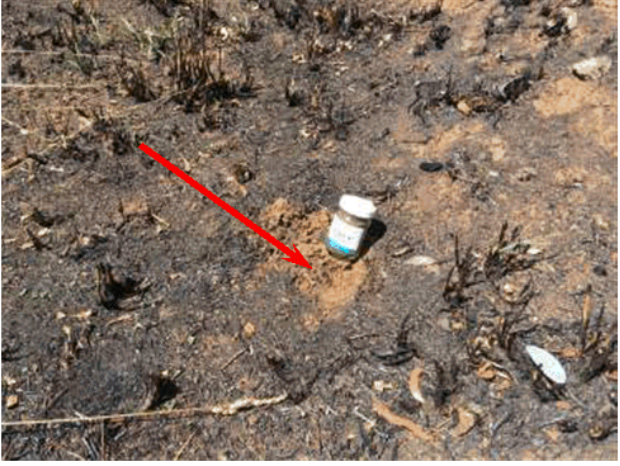
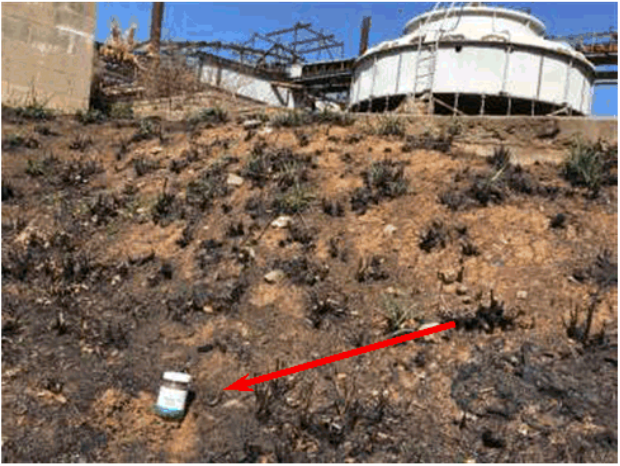
Sample Number	Locations (as per Plan)	Material	Photographs
864002 - 11	Evaporator unit 10m n/e	Soil - top 10cm

864002 - 11	Evaporator unit 10m n/e	Soil - top 10cm

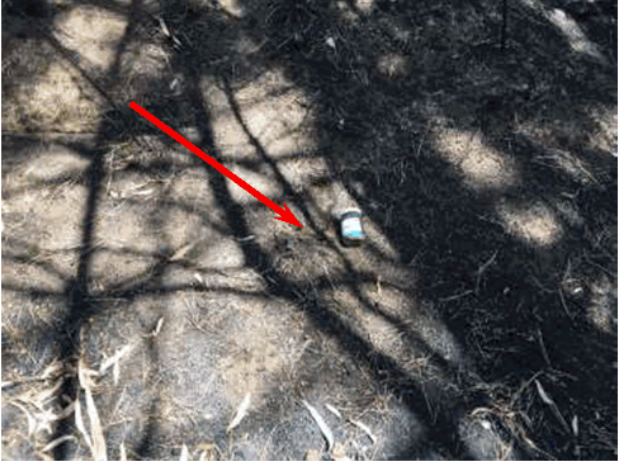
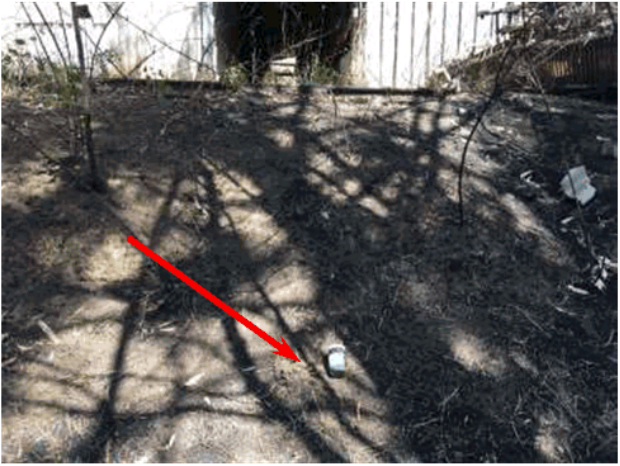
Sample Number	Locations (as per Plan)	Material	Photographs
864002 - 13	Building B 10m east of n/e corner of corrugated ACM wall sheeting section	Soil - top 10cm

864002 - 13	Building B 10m east of n/e corner of corrugated ACM wall sheeting section	Soil - top 10cm

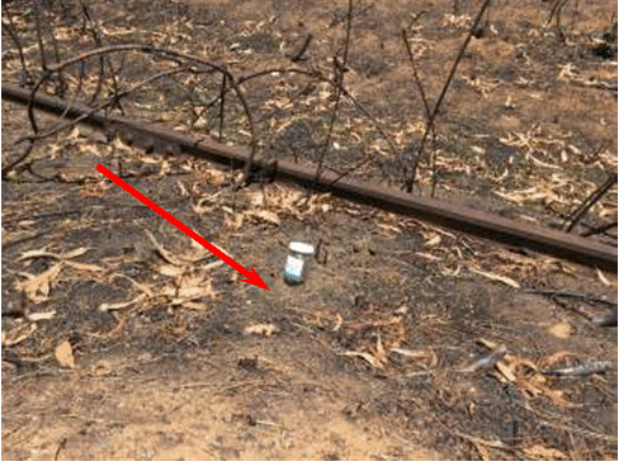
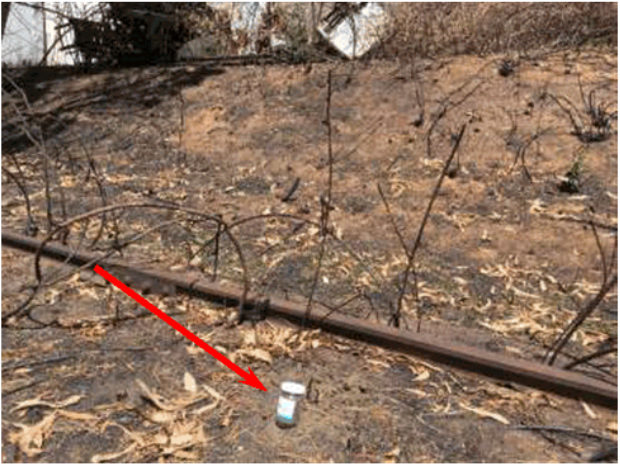
Sample Number	Locations (as per Plan)	Material	Photographs
864002 - 14	Building B 15m n/e of n/e corner of corrugated ACM wall sheeting	Soil - top 10cm

864002 - 14	Building B 15m n/e of n/e corner of corrugated ACM wall sheeting	Soil - top 10cm

SE202459.014	864002-14 Surface - top 10cm	Soil	142g Sand, Soil, Rocks, Plant matter	03 Feb 2020	No Asbestos Found Organic Fibres Detected	<0.01
SE202459.015	864002-15 Surface - top 10cm	Soil	229g Sand, Soil, Rocks, Plant matter	03 Feb 2020	No Asbestos Found Organic Fibres Detected	<0.01
SE202459.016	864002-16 Surface - top 10cm	Soil	182g Sand, Soil, Rocks, Plant matter	03 Feb 2020	Chrysotile Asbestos Found Synthetic Mineral Fibres Detected Organic Fibres Detected	<0.01
SE202459.017	864002-17 Surface - top 10cm	Soil	236g Sand, Soil, Rocks, Plant matter	03 Feb 2020	No Asbestos Found Organic Fibres Detected	<0.01
SE202459.018	864002-18 Surface - top 10cm	Soil	173g Sand, Soil, Rocks, Plant matter	03 Feb 2020	No Asbestos Found Organic Fibres Detected	<0.01
SE202459.019	864002-19 Surface - top 10cm	Soil	178g Sand, Soil, Rocks, Plant matter	03 Feb 2020	Chrysotile Asbestos Found Organic Fibres Detected	>0.01

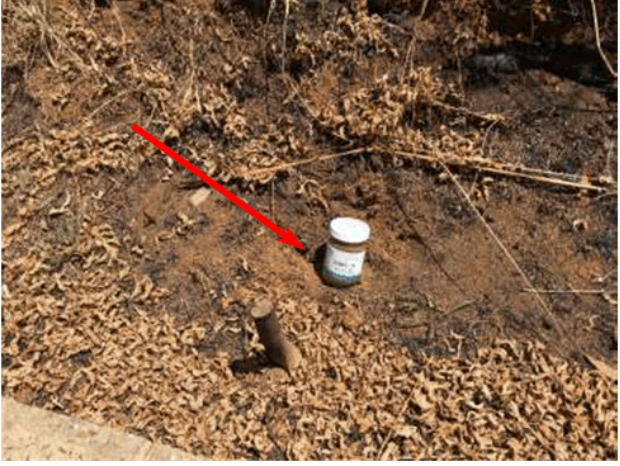
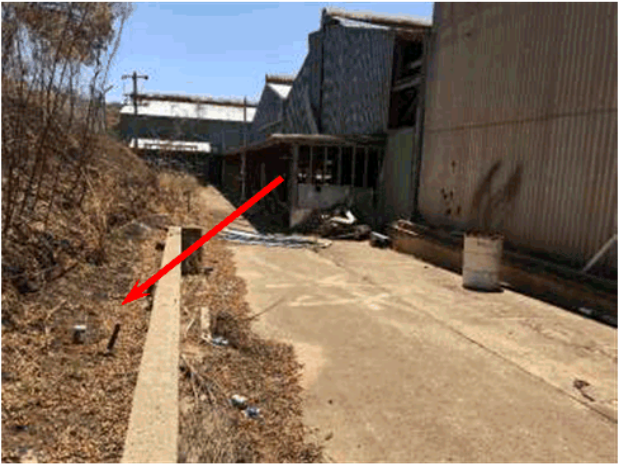
Sample Number	Locations (as per Plan)	Material	Photographs
864002 - 20	Building B 6m centre west of the corrugated ACM wall sheeting section	Soil - top 10cm

864002 - 20	Building B 6m centre west of the corrugated ACM wall sheeting section	Soil - top 10cm

RESULTS							
Fibre Identification in soil						Method	AN602
Laboratory Reference SE202459.020	Client Reference 864002-20 Surface	Matrix Soil	Sample Description 160g Sand, Soil, Rocks, Plant matter	Date Sampled 03 Feb 2020	Fibre identification No Asbestos Found Organic Fibres Detected	Est. fsw/w* <0.01

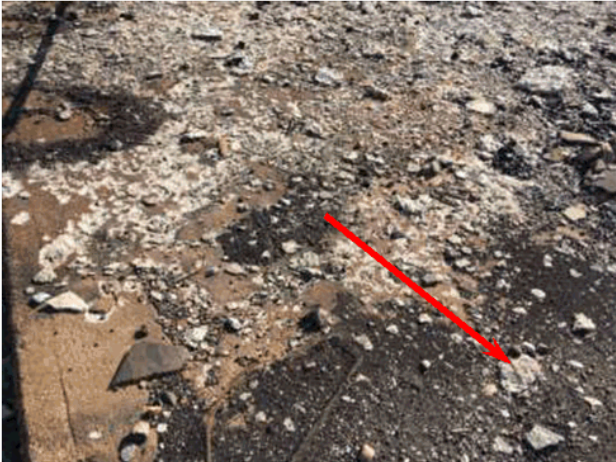
2	Building A southern side adjacent building footprint	Concrete fragments

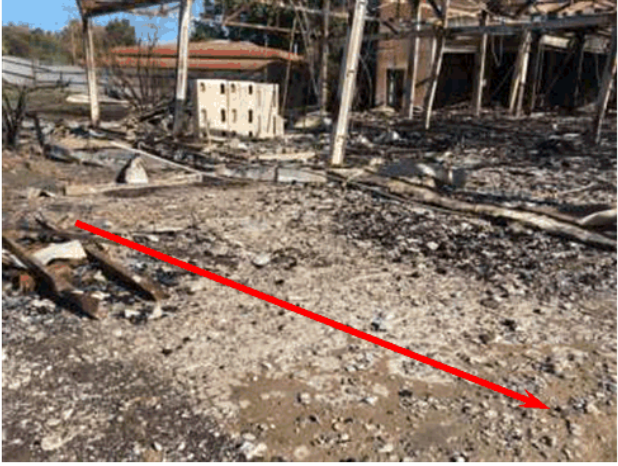
Photo Number	Locations	Material	Photographs
3	Building A southern side adjacent building footprint	Concrete fragments

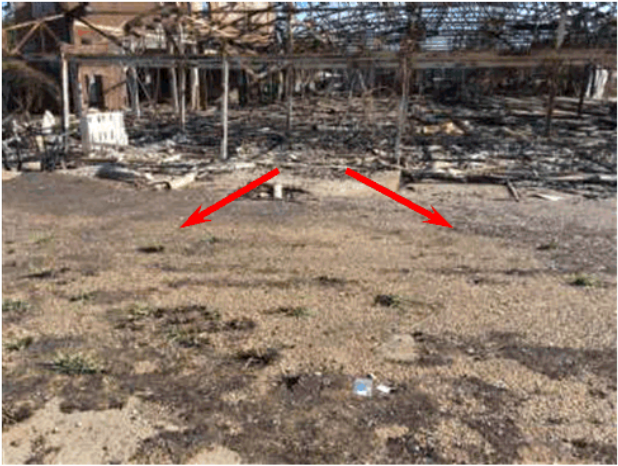
4	Building A southern side adjacent building footprint	Concrete fragments

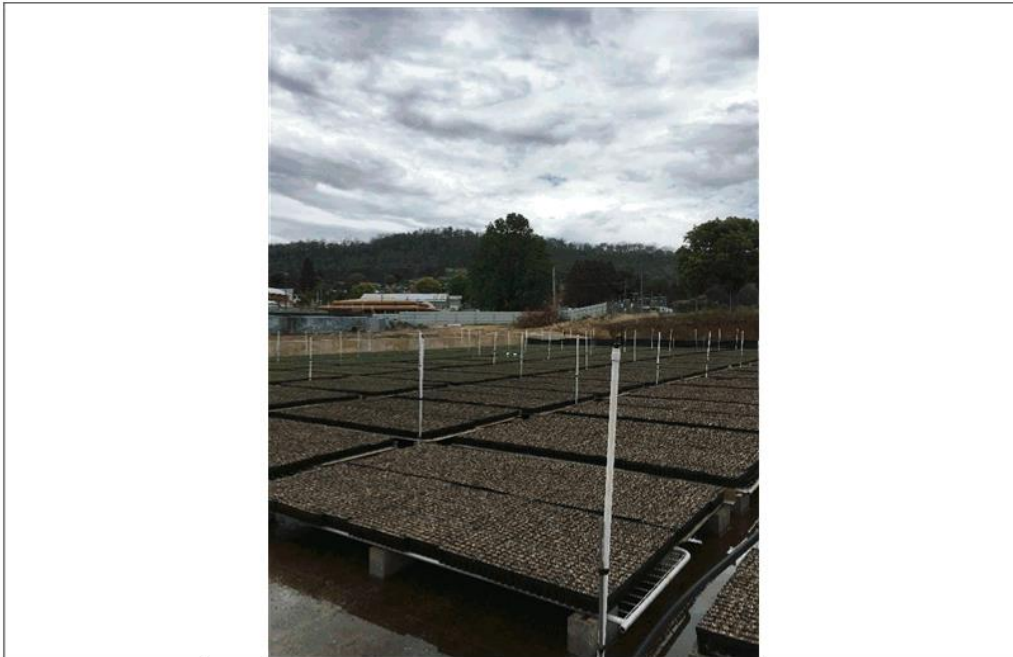
Photograph 5
Date: 1/12/2020

Current use of the south section of the site for horticultural purposes such as saplings in planter boxes with irrigation. View to the west.

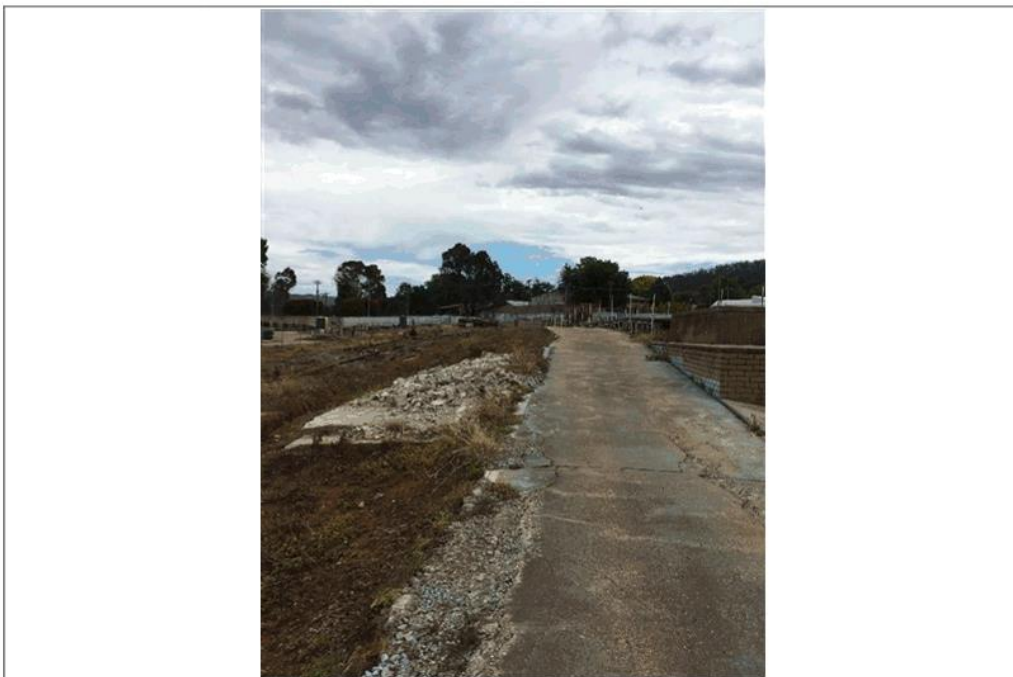
Photograph 6
Date: 1/12/2020

Concrete area along east section of the site, view to the south.

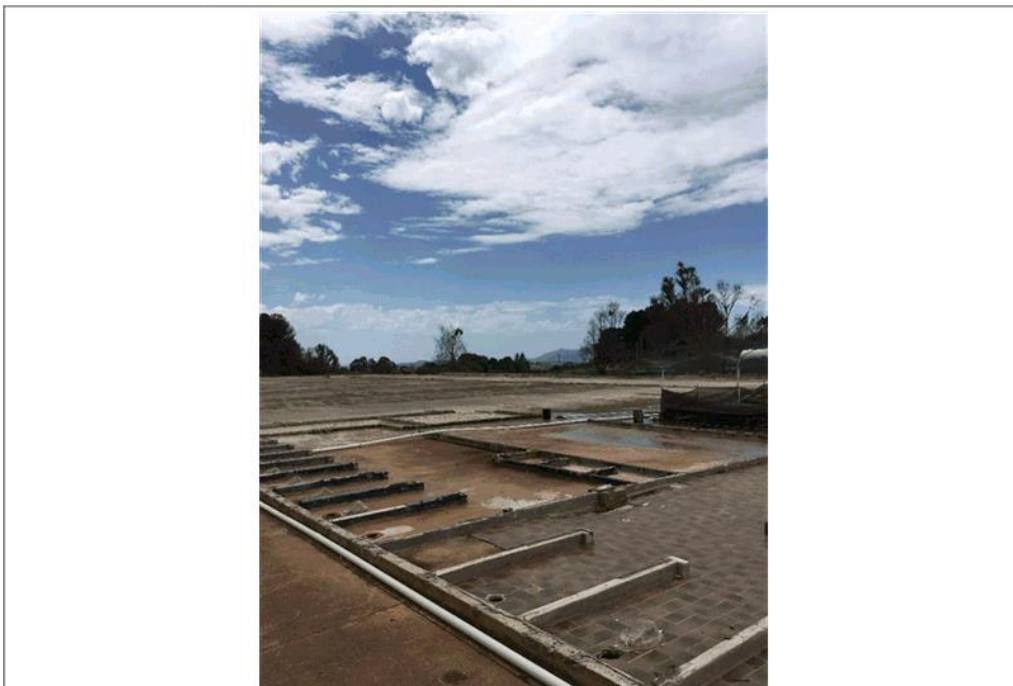
Photograph 8
Date: 1/12/2020

Former amenities block and concrete slab in centre of the site. View to the north.

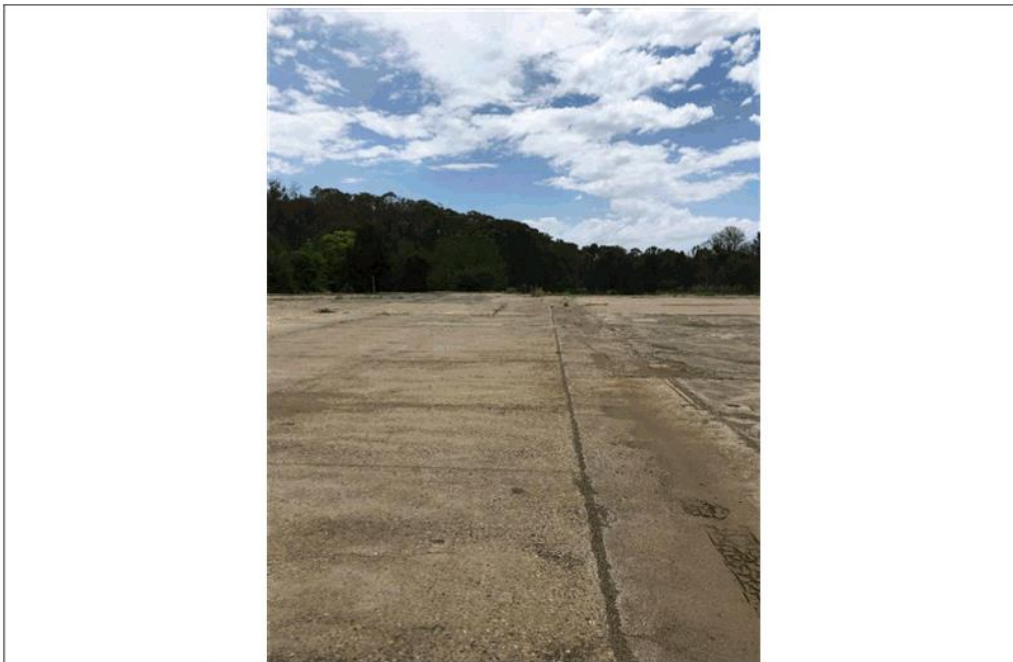
Photograph 9
Date: 1/12/2020

Concrete slab in the centre of the site. View to the north.

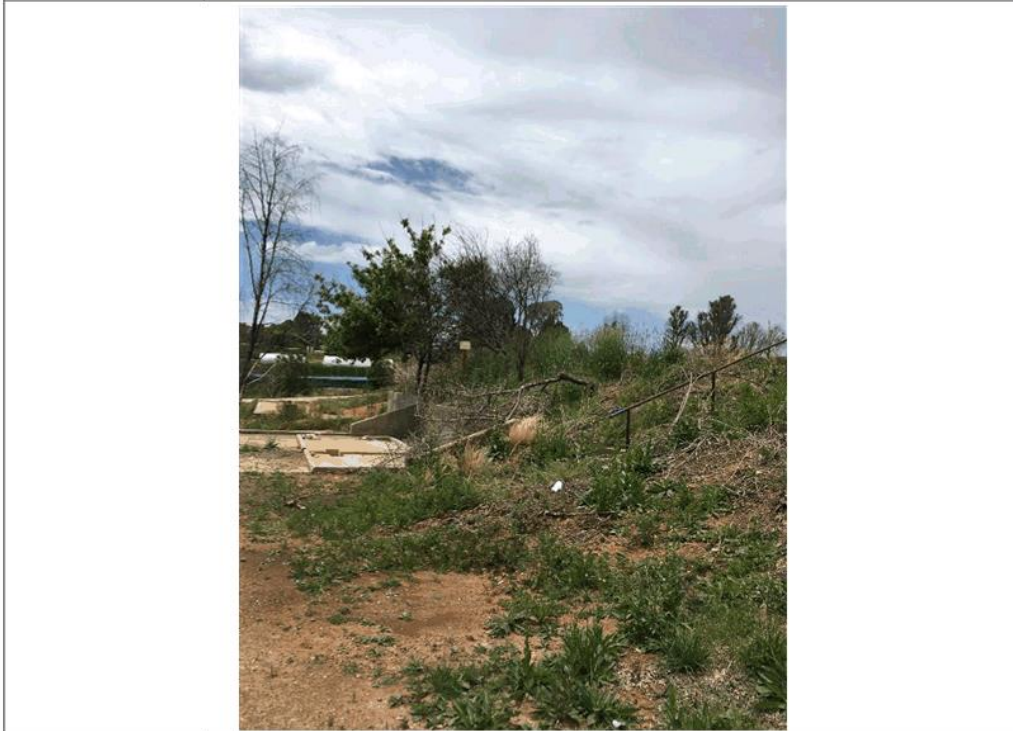
Photograph 10
Date: 1/12/2020

Slope showing the potential cut and fill in the north section of the site. View to the east.

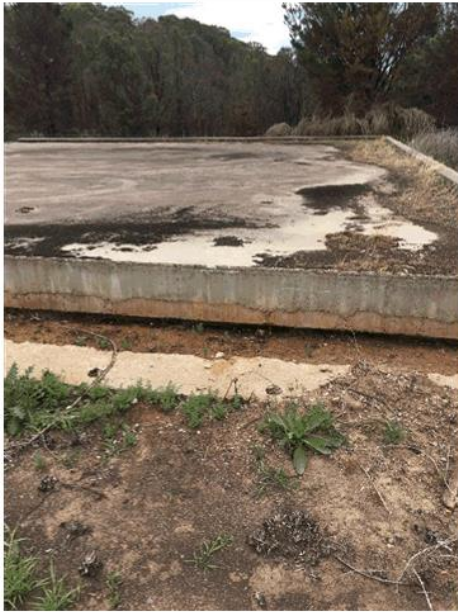
<p>Photograph 12 Date: 1/12/2020</p>	<p>Concrete slab in the north section of the site. View to the north.</p>

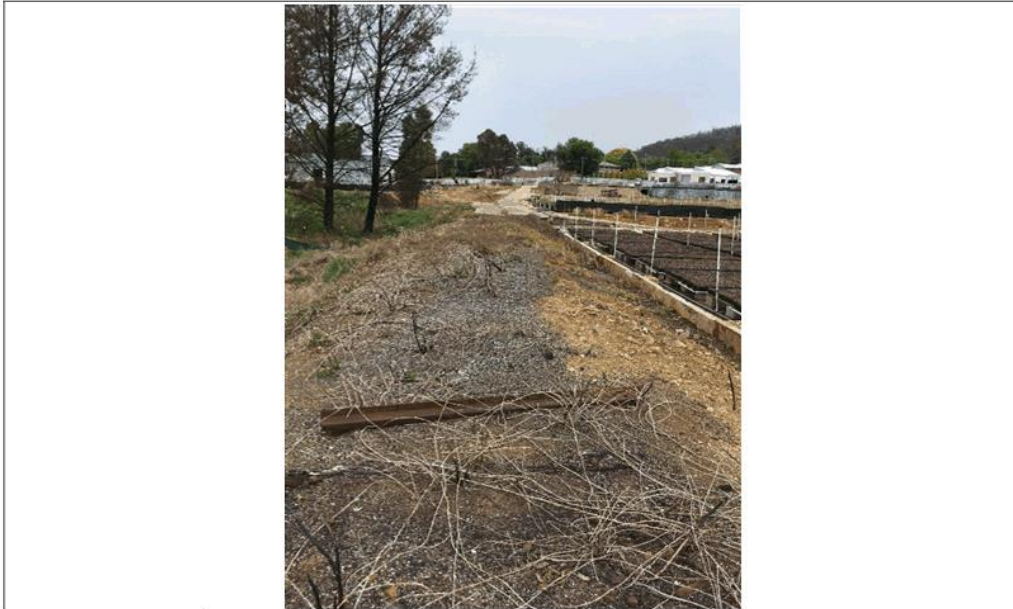
Photograph 13
Date: 1/12/2020

Offsite area of ash and slag located along the central east boundary of the site. View to the south.
