PRELIMINARY SITE INVESTIGATION

Former Batlow Cannery

1 Leaburn Avenue,

February 2021

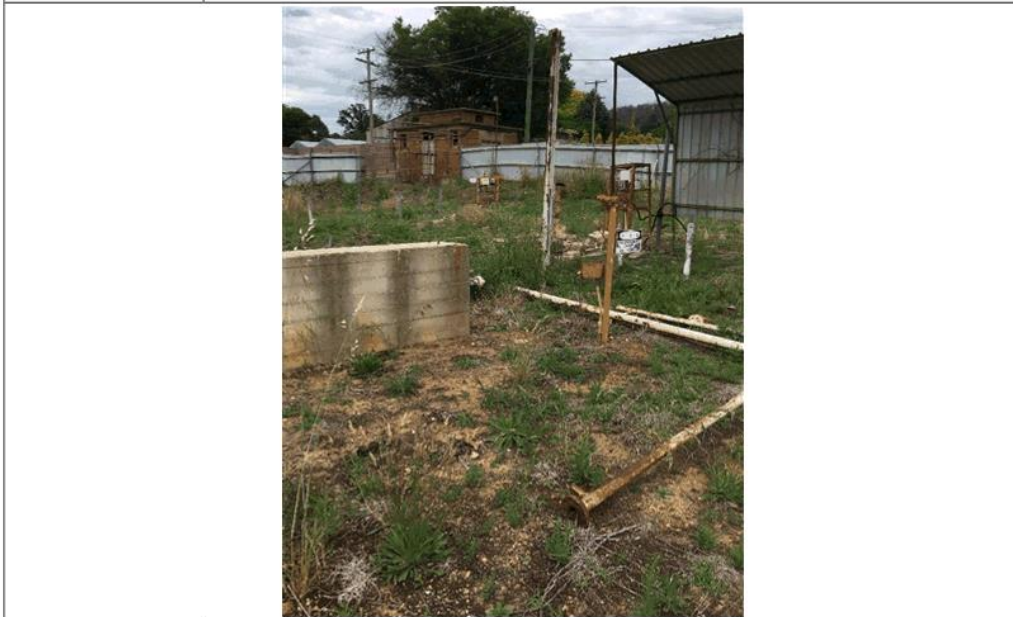
Photograph 14
Date: 1/12/2020

Former LPG AST area with remaining infrastructure. View to the south.

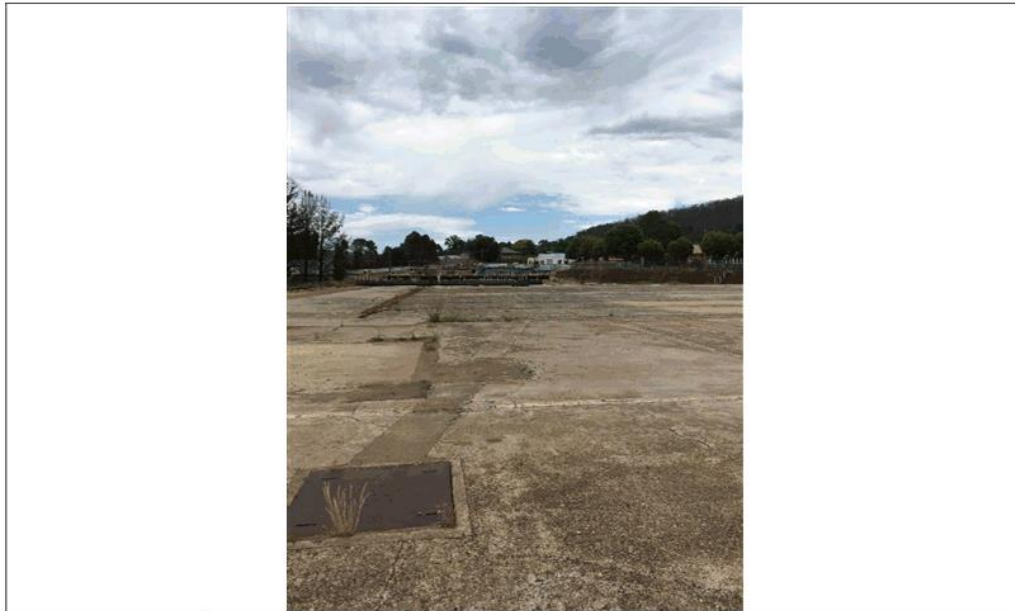
Photograph 17
Date: 1/12/2020

General view of site. View to the south.
